LANDSLIDES IN TAIWAN
SOME CASE REPORTS

ZA-CHIEH MOH

*Proceedings, Advisory Meeting on
Earthquake Engineering and Landslides
29 August - 2 September, 1977, Taipei, R.O.C.*

SYNOPSIS Seven case histories of landslides are presented in the paper. These slides are of the types which are common in Taiwan. The major causes for the slides were either due to saturation of the soil mass after a heavy rainfall or due to high pore water pressure developed in the subsurface strata. Preventative, control or remedial measures adopted are described.

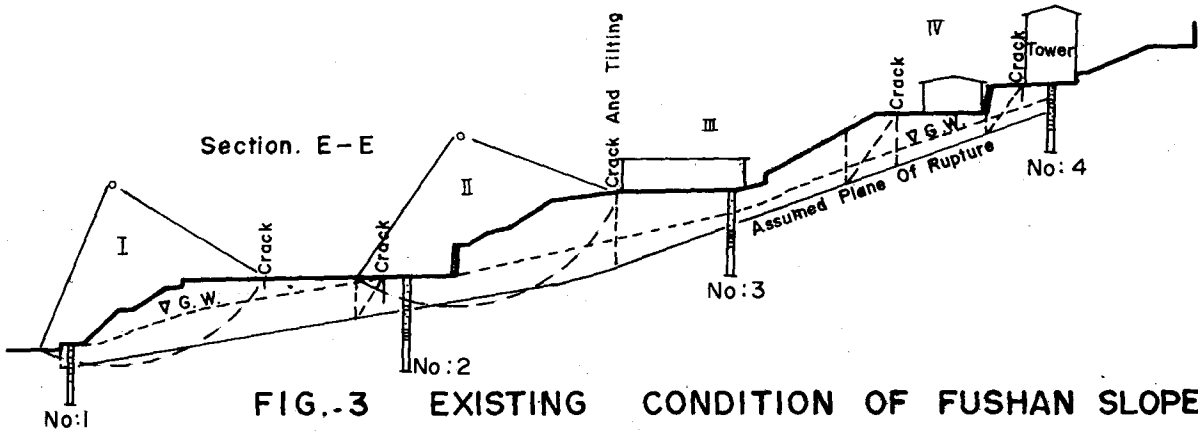
FIG. 3 EXISTING CONDITION OF FUSHAN SLOPE

In 1972, a series of slides occurred in the area after the construction of a ditch at the toe of the slope in connection with the widening of the Chungshan North Road. Several cracks opened on the slope parallel to the toe, with width varied from a few millimeters to several centimeters. The cracks cut through concrete floor slabs and brick walls of structures situated on the slope. Some of the observed movements indicated block slides whilst there were also evidence of rotational slides.

Laboratory test results indicated that the overburden silty and clayey soils are very sensitive to moisture. Even a small change in the moisture content could lead to significant decrease in the shear strength and thus stability of the slope. Stability analyses were performed on observed slides as well as on potentially dangerous slopes. The in situ shear strengths of the soil masses were evaluated by backfiguring from observed slips. Fig. 3 shows one of the critical sections. Results of stability analysis indicate that the slope has been in a delicate equilibrium condition. The shearing strength of the soil masses is barely enough to resist the active forces, including the superimposed loads, soil weight and seepage forces. Any disturbance of the balance such as digging of ditch at the toe, saturation of soil due to heavy rainfall, new constructions, and earthquake, would result in slides. The following recommendations were made in order to improve the stability condition of the area. They include:

The F.S. for all blocks was approximately 1.0

- (1) Repairing all faulty waterpipes, drainpipes and sewers.
- (2) Preventing excessive runoff water from percolating into the ground by landscaping and drainage control.

- (3) Lowering the groundwater table by installing two parallel underground drains on the slope to intercept seepage above the critical area.
- (4) Improving the stability of the lower part of the slope by increasing the weight of the toe, such as the use of gravity retaining wall.

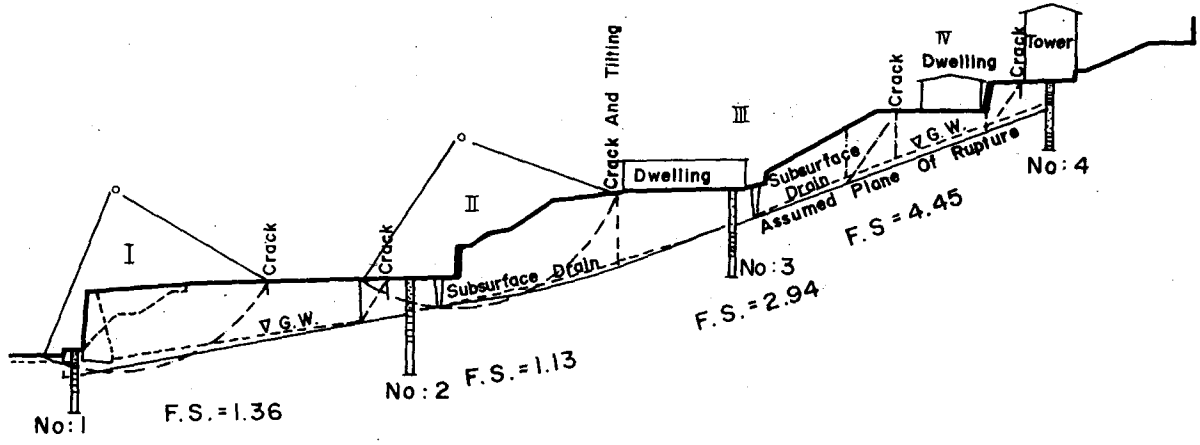
FIG. 4 CONDITION OF FUSHAN SLOPE AFTER IMPROVEMENT

If all these measures were executed the factor of safety of the slope would be increased to about 1.3 as shown on Fig. 4.

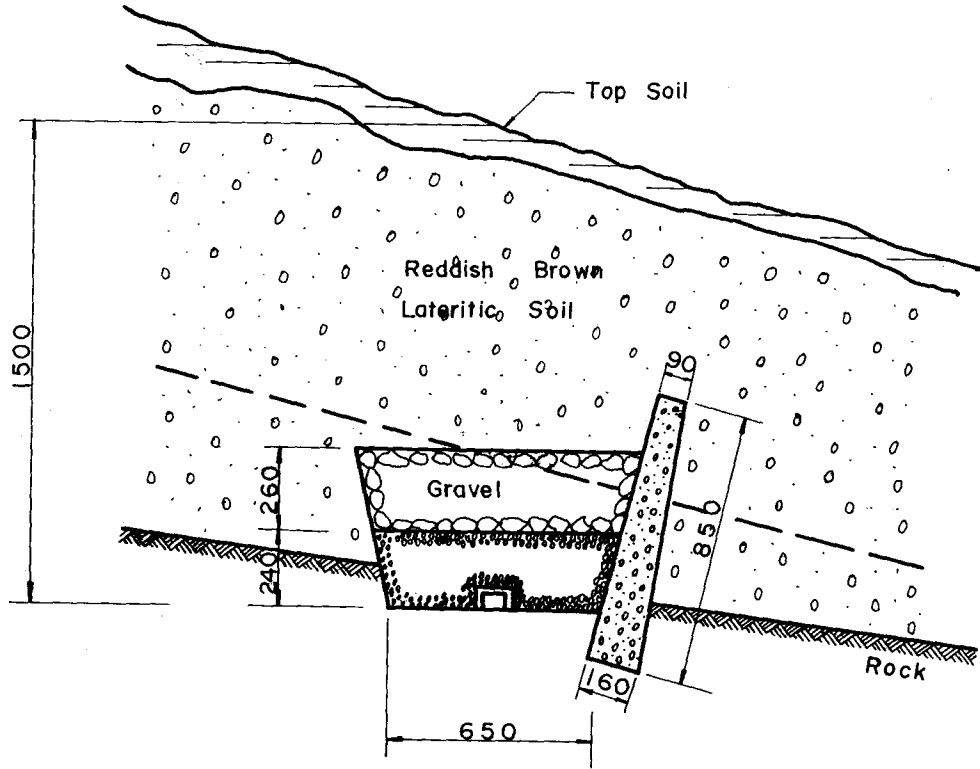
FIG. 6 DESIGN OF DRAINAGE TUNNEL AT STA. 62 K OF S-N FREEWAY

The South-North Freeway passes through Hu-Kou village and runs to south along the west margin of Hu-Kou terrace then down to Phon-Shan river. The cut area concerned, nearly 700 m in length, is located on the Hu-Kou terrace. The subsoil profile, as revealed by a series of 9 borings in the area, consisted of a 1 to 2 m thick layer of firm reddish brown lateritic soil overlying a layer of poorly cemented lateritic gravels and boulders which is roughly 10 m in thickness. Underlying the lateritic gravels are strata of soft to compacted siltstone and mudstone from the Pleistocene to upper Pliocene. The strata had strikes $N80^{\circ}W$ and dip $S5^{\circ}W$. Groundwater table in the area was found to be relatively high. Excavation of the cut intercepted the original groundwater flow path and it was found that water seeped out on the surface of the cut slope. The seepage obviously had caused a reduction of the effective stresses and softening of the soil masses and thus brought the slope to a critical condition.

The remedial scheme adopted is the use of drainage tunnel. A series of 5 vertical shafts were driven down to suitable depths. Shafts were then connected with a horizontal adit. The drainage tunnel collects water from the east and drains gravitationally to the drainage system at the foot of the cut slope. Fig. 5 shows a layout plan of the drainage tunnel scheme and Fig. 6 shows a schematic drawing of the design.

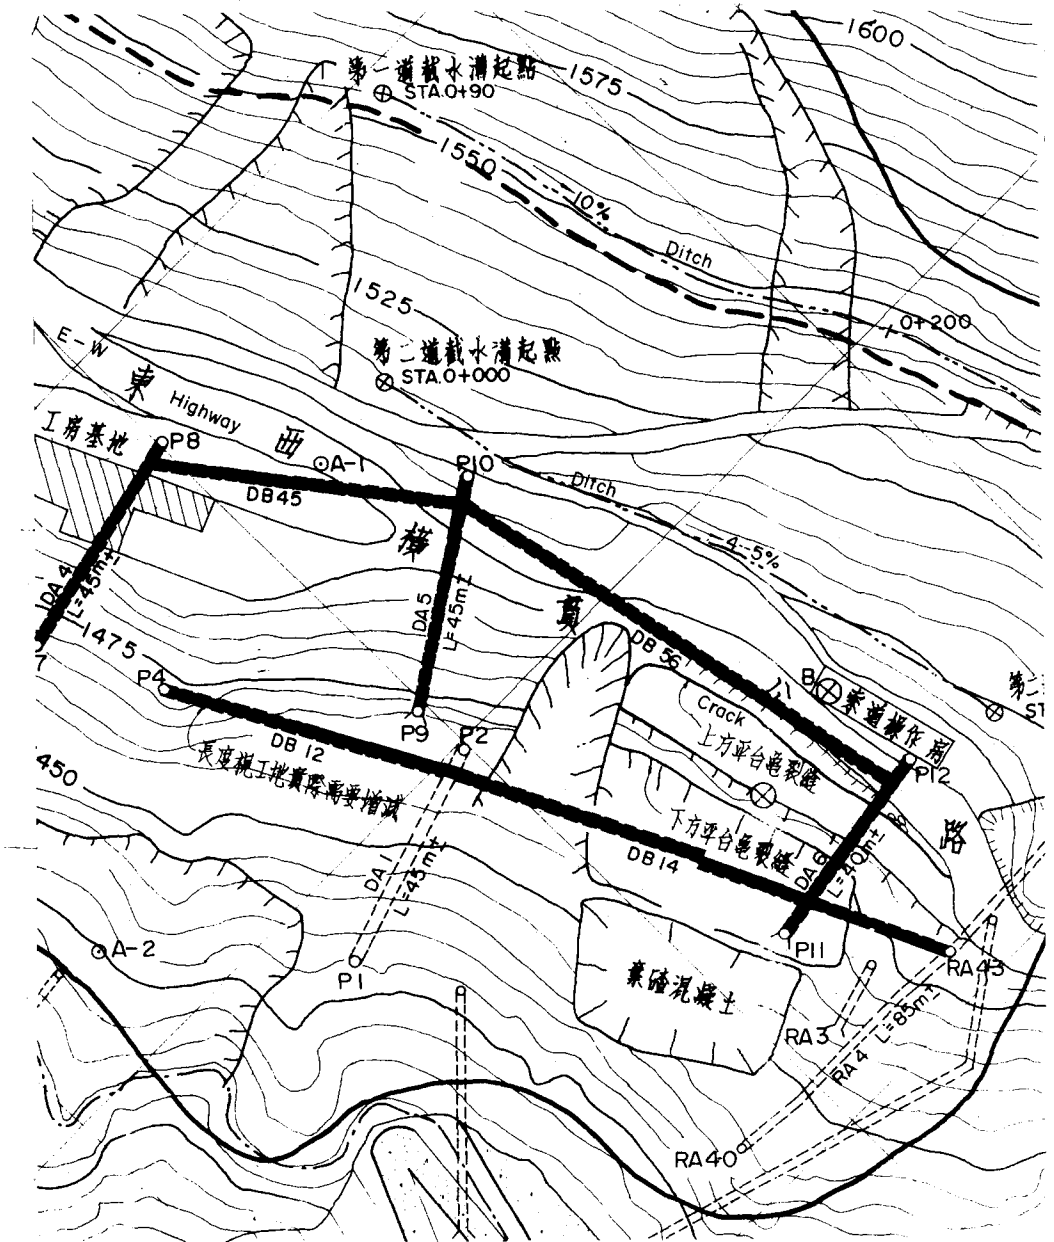
FIG. 8 SITE PLAN SHOWING DRAINAGE SCHEME FOR PI-TAN CHI LANDSLIDE

This landslide is located at the upstream of Ta-Chia Chi, one of the largest river in western Taiwan at Tai-8 of the E-W Cross Island Highway Sta. 63 k + 700 m. As shown in Fig. 7, the sliding area is situated close to the spillway and intake structures of the Teh-Chi Reservoir. Prior to and during the construction of the reservoir, slope failures had occurred several times. Attention has been given to the safety of the construction of the spillway structure. Some bank protection measures including land reformation and buttress structure at the toe of the unstable slope have been carried out. Several slope indicators were installed to monitor the displacement of the slope. According to the records of the slope indicators, the slip plane located somewhere at the depth of 30-35 m below the ground surface, and was in the loose superficial slope out-wash or in the highly weathered slaty rock. The endangered area consisted of a steep slope at about 35-40 degrees. The excavation of the E-W Cross Island Highway destroyed the vegetation cover planted on the slope and bared the underlying rock to air-slacking. After the completion of the Teh-Chi Reservoir, it was reported that the sliding area appeared to be gradually enlarged and becoming more unstable.

A remedial measure was proposed and construction was completed in early 1977. The primary purpose of the remedial scheme is to lower the groundwater table and to intercept surface runoff. Several shafts about 50 m long were driven normal to the surface of the slope at different elevations. These shafts are connected by a longitudinal shaft as shown in Fig. 8. Open ditches were constructed along the sliding area to intercept surface runoff. Further investigation of the mechanism of this landslide and the effectiveness of the remedial measures is underway.

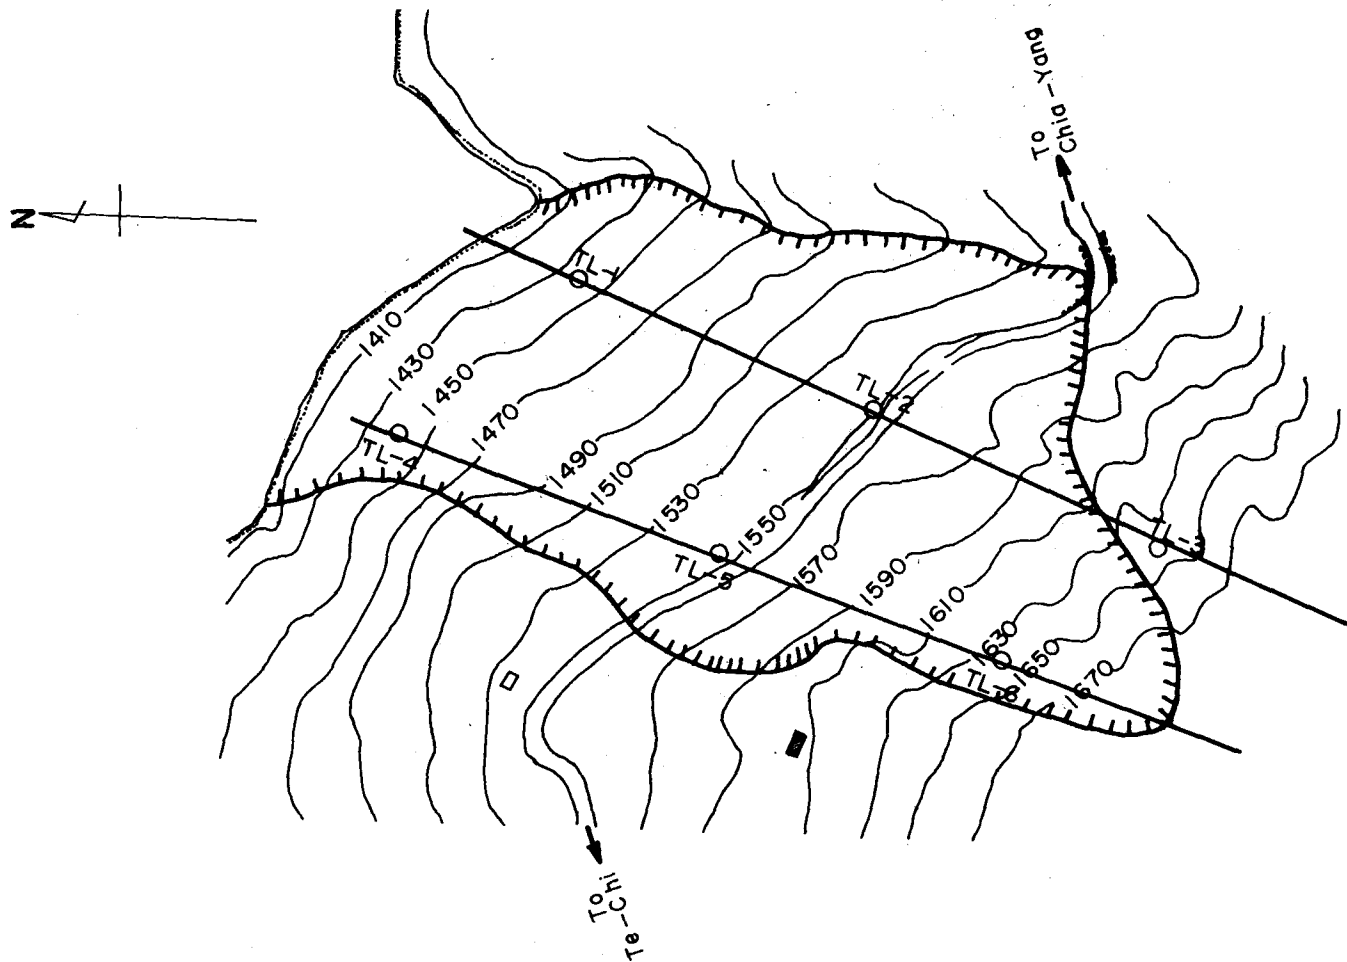
FIG. 9 SITE PLAN SHOWING EXTENT OF CHIA - YANG SLIDE

typical old landslide. It seems that the sloping area was well recovered. After the completion of the Teh-Chi Reservoir, change of the groundwater condition destroyed the stress equilibrium of the stability. A sudden failure of the slope in this old sliding area took place in October, 1975, after a heavy storm and prolonged raining season and blocked the highway traffic for about one month. The surface of the E-W Cross Island Highway settled for about 20 m. Immediate action including drilling to clarify the depth of the unstable material and removal of partial sliding material have been taken. Fig. 9 and Fig. 10 show that the slip plane located about 20-35 m below the surface. It is estimated that the sliding material liable to slide down into the reservoir is at least 1,000,000 cu.m. At the present, about 20,000 cu.m. of the sliding material resting on the slope above the highway has been removed. Recent heavy rains in June have proven that reducing of the loading by removing part of the sliding material did work well.

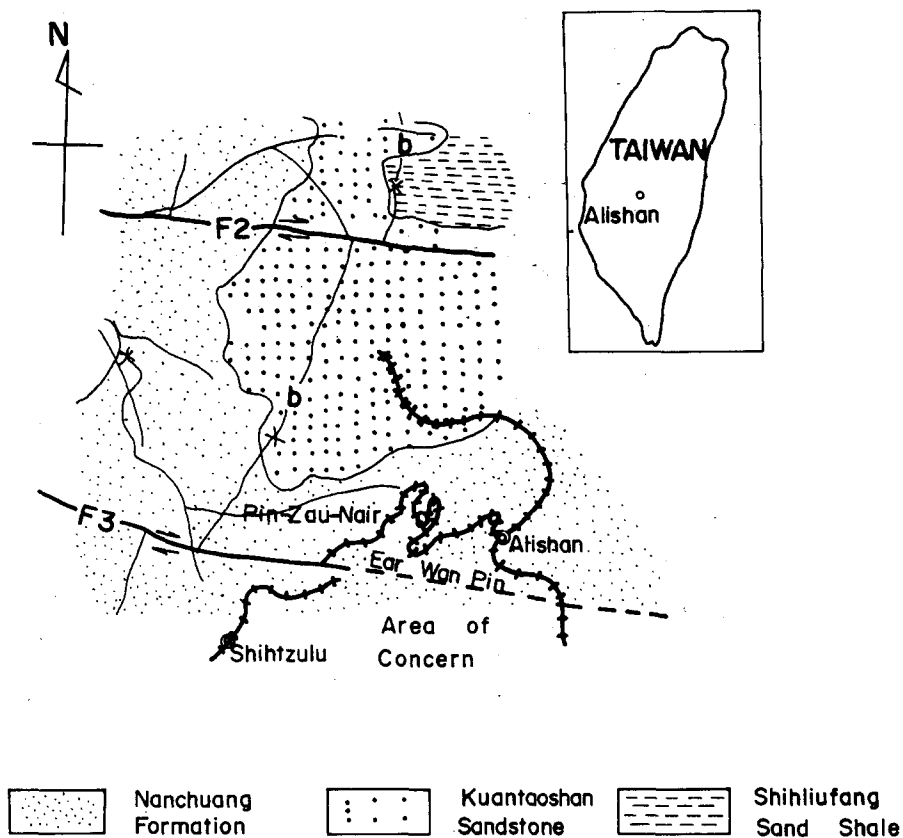
FIG. II GEOLOGY OF LANDSLIDE AREA AT
PIN-ZAU-NAIR

The area concerned is located about 750 m south-east of the Pin-Zau-Nair Station of the Alishan Forestry Railroad. In geological terms, it is situated between the Luchushan syncline of the Kiuantaoshan sandstone, Keichulin formation and north of the Shihtzulu fault of the Nanchuang formation as shown in Fig. 11. A typical profile is shown in Fig. 12. In this area, the slopes are steep, the rock formations are rather weak and heavily fractured. The Alishan Forestry Railroad cuts across this fracture zone, and numerous slides took place after heavy rainfalls. A study was undertaken by the Department of Soil and Water Conservation of the National Chung Hsing University for the Taiwan Forestry Bureau in 1971 to study causes of slides and to determine methods for slide control (CHOU, 1973). The study program included topographic survey, extent of landslide area, temperature variation, geological formation, groundwater conditions and various types of laboratory tests in determining the physical characteristics of the rock formation. Some of the salient results obtained from the extensive investigation are summarized below:

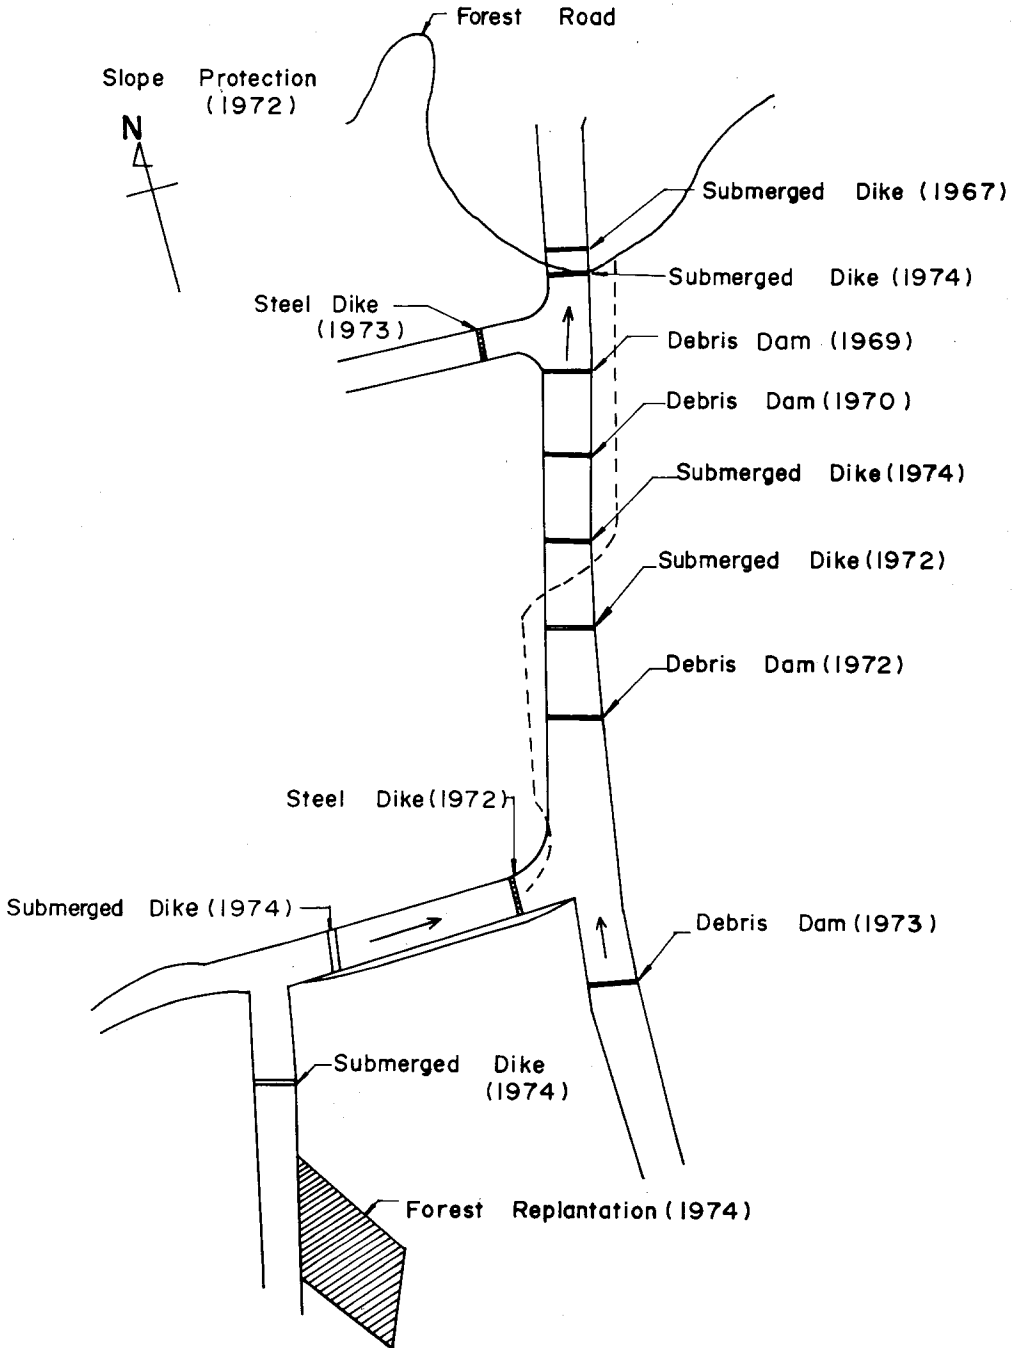
FIG. 14 SITE PLAN SHOWING LOCATION OF CONTROL WORKS AT TU - CHAN - CHI

The geology of the area belongs to Wulai Group of the Oligocene consists of mainly black slate and shale, interbedded with quartzite sandstones. The formation had undergone considerable geotectonic movement and developed many faults. Most of the surface layers of the rock formation are highly fractured and distorted. These materials are easily weathered particularly in subtropical climate with heavy rainfalls. The overburden soils in the area are primarily gravelly, sandy silts and gravelly clays with rock fragments. At many localities, due to the steepness of the slope, the overburden had been eroded and the rock formation was exposed. At the time of the Typhoon Gloria, the heavy rainfall has caused numerous landslides. The flood water of the Tu-Chan Chi carried large volume of debris downstream which in turn caused further erosion of the river banks. The total area affected by the landslides exceeded 33 hectares.

The treatment plan which took place in a 4-year period was essentially a soilwater conservation scheme which involved control of river flow, reducing slope of the river bed, reducing bank erosion, stabilizing river bed and toes of hill slopes, control of landslide and its vegetation coverage. Construction included a series of submerged dams, debris dams, steel dams, and slope protection measures as shown in Fig. 14.

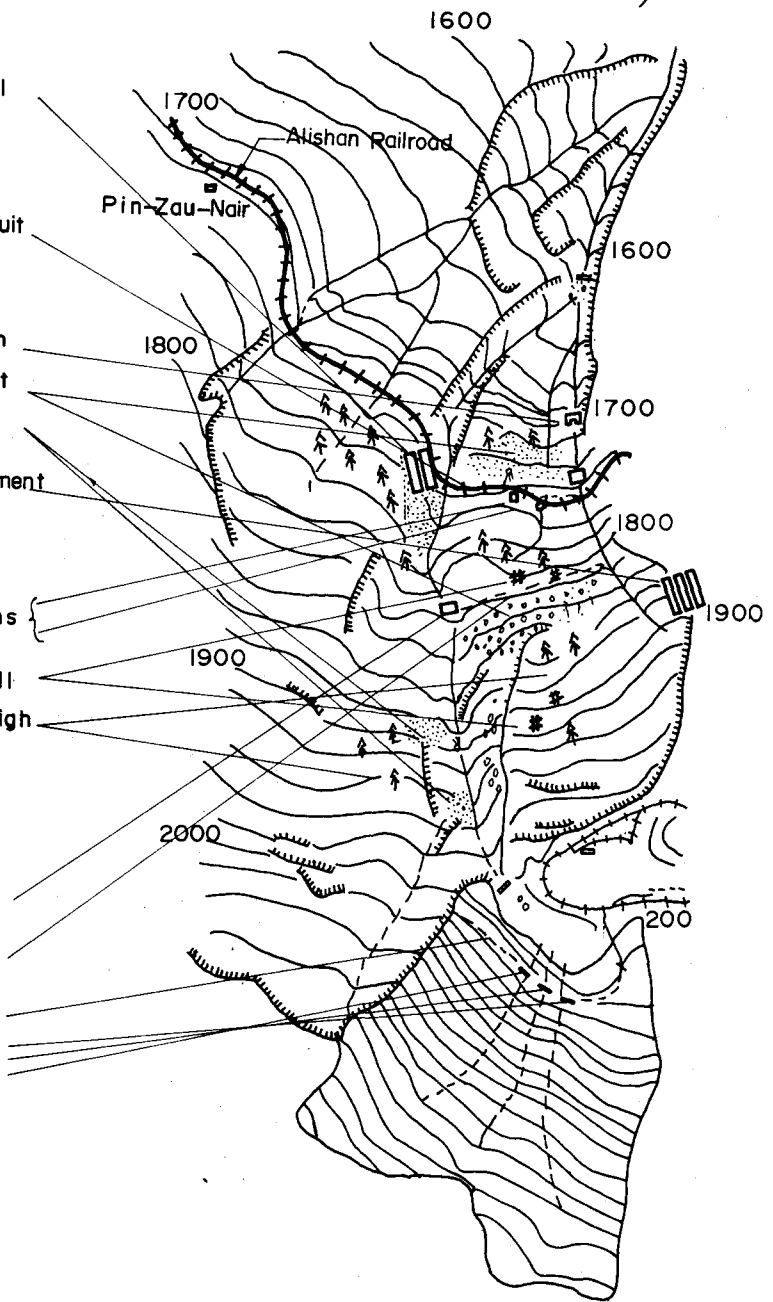
FIG. 13 SITE PLAN SHOWING LOCATIONS OF CONTROL WORKS, PIN - ZAU - NAIR AREA

From results of the study, it was concluded that the primary cause for the landslide in the area was due to movement of the groundwater. It was necessary to control the rate of subsurface water flow as well as the gradient of the groundwater. For slide control and stabilization, it was suggested that a combined soil conservation scheme including construction of preventive structures, forest plantation, and erosion control should be adopted. A scheme for treatment and control was proposed which include the following measures, as shown in Fig. 13.

- (A) Treatment for surface runoff by constructing water saving dams and diversion culvert.
- (B) Treatment for subsurface water by using pumping wells and longitudinal drainage wells.
- (C) Surface stabilization by constructing retaining walls and replantation.
