EMERGENCY REHABILITATION OF CONCRETE
PAVEMENT SECTION OF AN
AIRPORT RUNWAY

Moh and Associates, R.O.C.

*Proceedings, Second Conference of the Road
Engineering Association of Asia and Australasia,
Manila, October 1978, Vol. III, pp. 28-36*

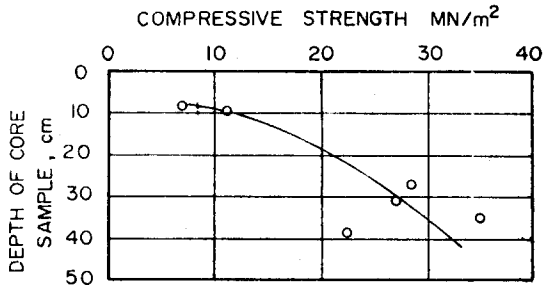
FIG. 3

Fig. 2 shows that the actual thickness of the concrete surface of the pavement varied from 30 cm to 58 cm. A series of compression tests was performed on the concrete cores obtained from drilling. Results in Fig. 3 show that the concrete strength decreased with depth from the surface. Ten centimeters below the pavement surface, the concrete had an average compressive strength of only 8.83 MN/m^2 . Even at a

depth of 40 cm, the concrete strength was still quite low, around 28.44 MN/m². There are several factors which can be considered to be responsible for these low strength values. They include localized overstress, differential settlement, fatigue, aging, weathering action, and also possibly poor quality during construction.

Fig. 3 Variation of Concrete Strength with Depth of Core Sample

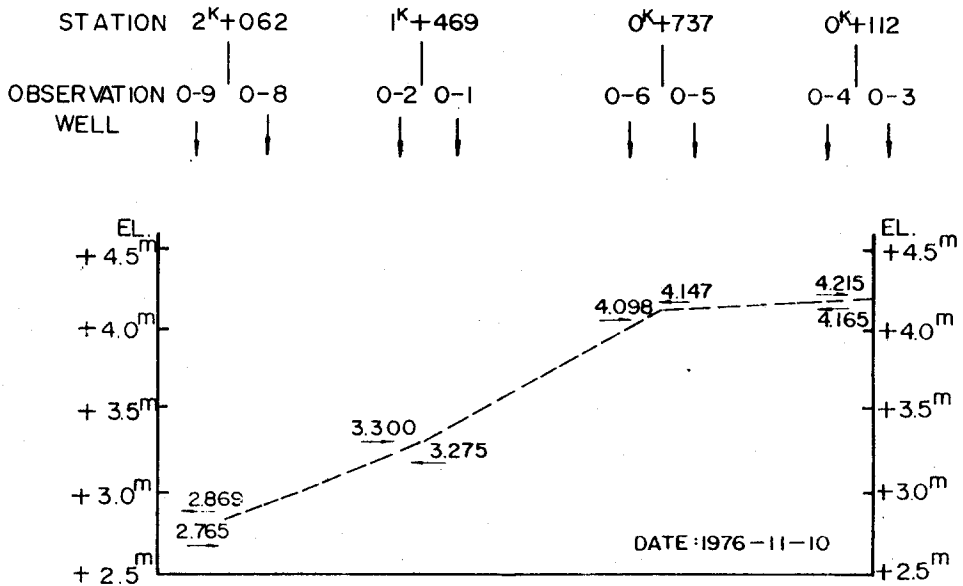
FIG. 4

(B) Localized excess pore water pressure — According to the pavement design section, the average thickness of the concrete surfacing was 35 cm and the thickness of the base course was 34 cm. Fig. 4 shows that the static groundwater surface existed at a depth of about 1.2 to 1.4 m below the pavement surface. In other words, there should not be any positive pore water pressure existing in the base course. During maintenance and repairing work near Station 1 + 260, water was found flowing upward from the base course. Subsequently installed piezometers in the base course indicated that the pore water pressure level reached 10 to 50 cm below the surface, i.e. there was an excess pore water pressure equivalent to about 1.1 to 0.6 m of water head.

Fig. 4 Static Groundwater Level during Dry Season

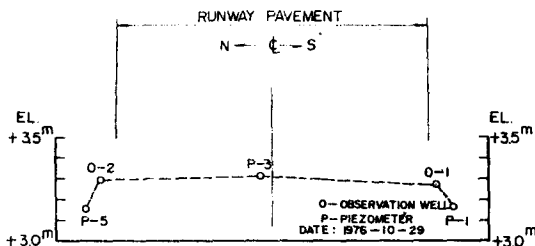
FIG 5

Within the area of runway pavement, the pore water pressures in the subgrade increased due to the aircraft loading. Due to low permeability of the subgrade and poor drainage condition, the excess pore water pressure could not dissipate easily. Consequently the pore pressures under the pavement were higher than those outside the pavement, as shown in Fig. 5.

Fig. 5 Pore Water Pressures in Subgrade at Station 1 + 469

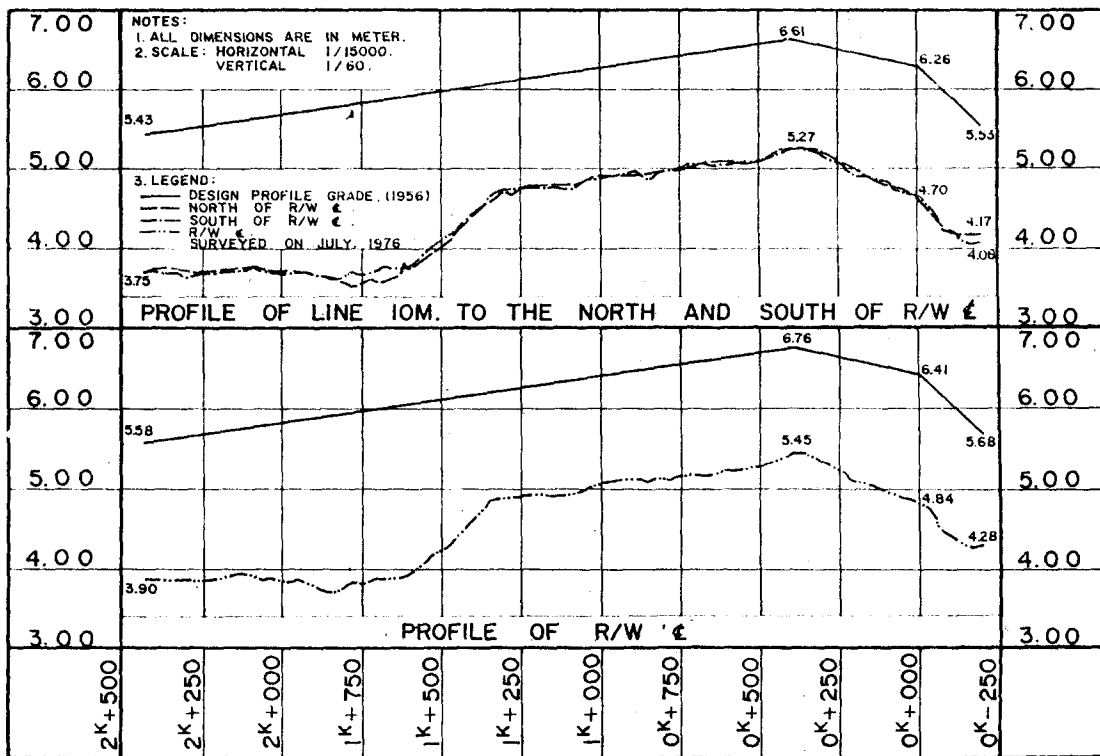
Fig. 6 Runway Profile

the runway elevation has been continuously settling. The settlement can be attributed to two main courses: (i) the general subsidence of the Taipei Basin due to deep well pumping, and (ii) consolidation settlement of the subsoil due to the runway and aircraft loading. Fig. 6 shows the elevations of the runway surveyed in August 1976. Comparing with the elevation at the time of construction (1956), the average settlement of the runway during the 20 years time ranged from 130 to 220 cm. The amount of settlement which can be attributed to subsidence varied from 70 to 100 cm. Therefore, the relative settlement of the runway due to loading ranged from 50 to 130 cm. Table 1 shows the settlement values for the various sections of the runway. It can be seen that considerable amount of differential settlement had occurred. The most serious section was near Station 1 + 750 with a maximum relative settlement of 130 cm. Due to the wind direction, most the take-offs and landings at the Taipei Airport took a west to east direction. The section between Stations 1 + 350 and 2 + 000 is considered to be the most critical area which experiences more concentrated loading (rear wheel) during take-offs and braking forces during landings.

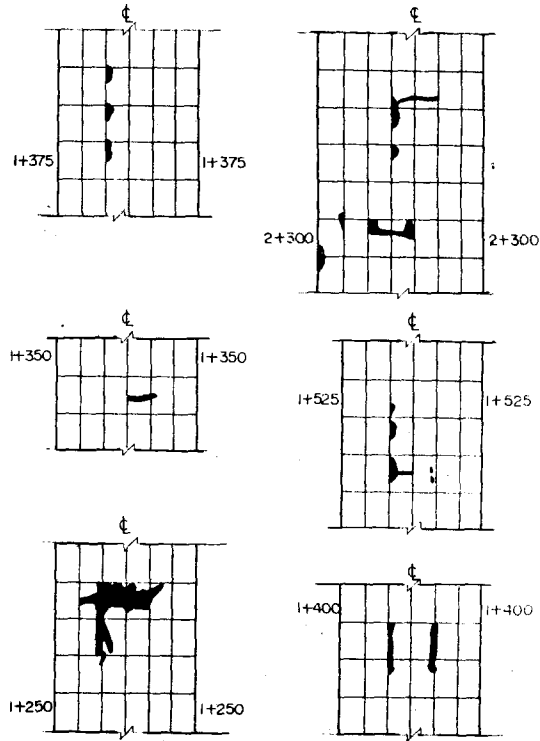
FIG 7

A detailed examination of the pattern and distribution of pavement damages was made throughout the entire runway. In general, cracking patterns could be divided into four types. They are: (i) corner cracks, (ii) joint cracks, (iii) diagonal cracks, and (iv) deterioration after minor repairs. Fig. 7 shows schematic diagrams of the deterioration conditions of some of the pavement panels. Survey results further showed that majority of the cracks and damages concentrated within the range of the mid-third width of the runway. The most serious condition occurred in 8 panels at Station 1 + 265 which had cracks distributed over the entire panels and were

beyond regular repairing. These panels located in an area generally referred to as the "landing zone" where brakes of the aircrafts are applied after landing. Heavy loading, high moisture content (about 44%) in the subgrade, large settlement and deterioration of concrete quality (the concrete core from this area has lowest strength value) all contributed to the poor condition of the pavement. In order to maintain flight safety, it was decided that an emergency rehabilitation program must be devised for this area.

Fig. 7 Damages of Concrete Pavement Surfaces

10. EMERGENCY REHABILITATION PROGRAM

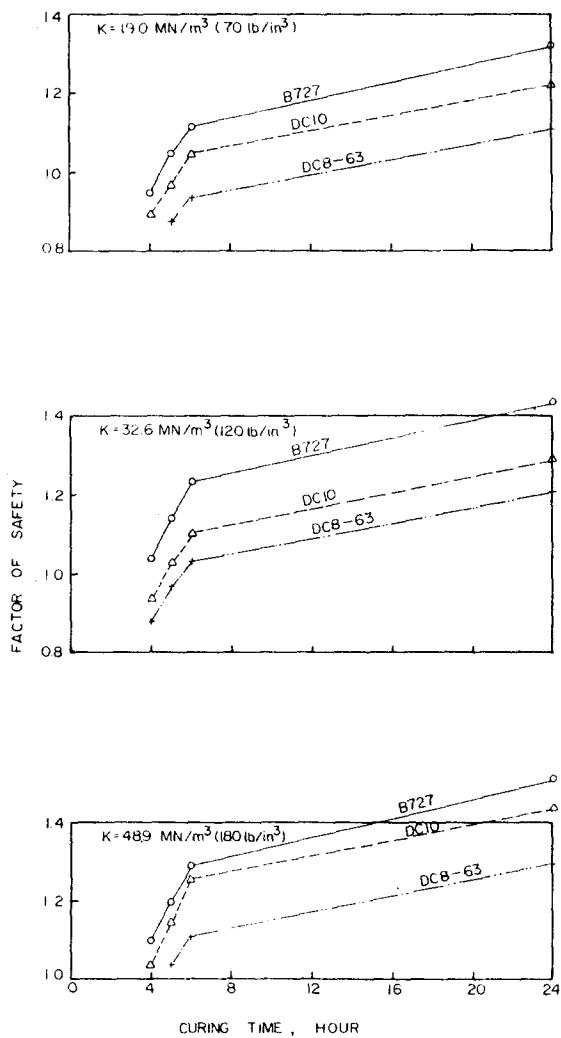
FIG 9

For the Taipei Airport, the heaviest aircrafts involved are Boeing 747 and DC-8 and the most frequently used type of aircrafts is Boeing 727. Although the commonly used factor of safety for repetitive loading is between 1.5 and 1.7 (PACKARD, 1973), the safety factor required for the concrete after 4 hours curing can be much lower for two reasons. Firstly, at the Taipei Airport, there are only very few civilian airline flights in the early morning hours which use Boeing 747 or DC-8. Secondly, the strength of the new concrete, in other words the safety factor, increases with time. It was therefore concluded that a compressive strength of 13.79 MN/m^2 ($2,000 \text{ lb/in}^2$) after 4 hours curing can be considered to be adequate for the purpose of emergency repairing work provided that the base course is properly recompacted.

Fig. 9 Relationship between Factor of Safety and Curing Time for Accelerator Treated Type III Cement Concrete
