CONSTRUCTION FAILURES OF EXCAVATION IN SOFT CLAY-CASE STUDIES

T.C. Kao, C.H. Wang and Z.C. Moh

*Reprinted from
Proceedings, 8th Asian Regional Conference
on Soil Mechanics and Foundation Engineering
Vol. 1, pp. 297-300
Kyoto, 1987*

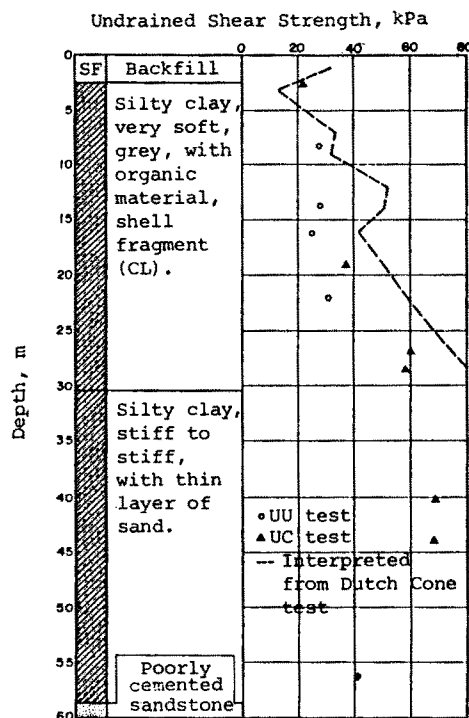
Fig. 1 Subsoil Conditions

Underneath the silty top soil is a layer of very soft, organic, dark grey silty clay with a thickness of approximately 30 meters. The blowcounts of this layer varies from 2 to about 6. The undrained shear strength (s_u) of this layer was determined from laboratory unconsolidated undrained shear strength tests, unconfined compression tests and from field Dutch Cone Penetration tests. Underlying this soft silty clay is a layer of medium stiff silty clay with a thickness of approximately 20 meters. Below the stiff clay layer is a layer of poorly cemented sandstone.

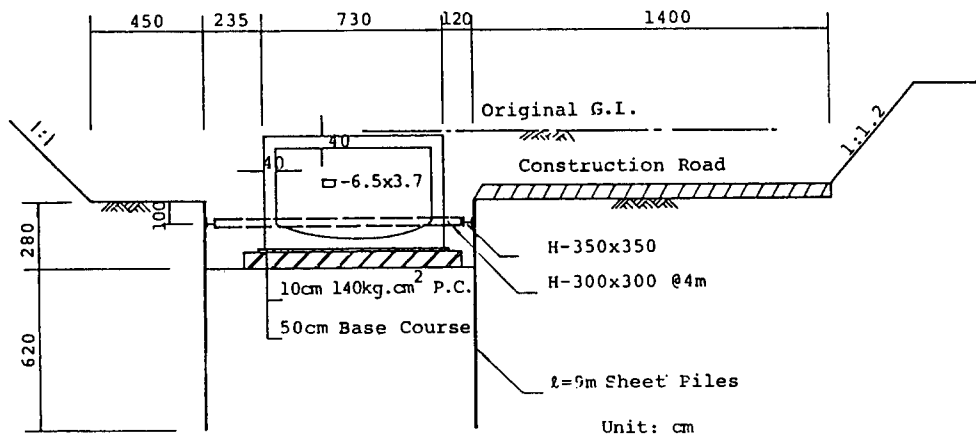
Fig. 2 Design Cross Section

The planned storm drain through this area is a 6.5 meter width by 3.7 meter height box drain. The drain consists of precasted sections in 1 meter length. The invert of the drain is at 4 to 5 meters below grade. To maintain the stability of the excavation, steel sheet piles and internal strut systems were utilized. The design cross section is presented in Fig. 2. During excavation, excessive heaving at the bottom of the excavation area and severe tilting of the retaining sheet piles occurred. A Simplified cross section illustrating the condition of failure is presented in Fig. 3. A field investigation was commissioned to investigate the cause of failure. It was found that although the laboratory and field testing results indicated that the soft clay layer had an undrained shear strength (s_u) of 20 kPa, its remolded strength was only 5 kPa. The subsoil had a sensitivity of about 4. The undrained shear strength of the soil at the failure site, back-calculated from the failure plane, was

found to be about 9.5 kPa which was about half of what was determined from laboratory and field tests. The failure could be attributed to reduction of soil strength due to construction which has induced disturbances.

Short wooden piles were recommended to alleviate the heaving within the excavated area and to prevent the tilting of retaining sheet piles. Wooden piles of 4 meter long, 15 cm in diameter and spaced at 40 cm were driven below the excavated area. The wooden piles provided downdrag resistance to the soil, which tended to expand and heave due to removal of the overburdens. The wooden piles also provided a firm mat foundation which has significantly reduced settlement of the box drain after backfilling. During the excavation stage, the wooden pile mat could also provide similiar effects as internal struts to the retaining sheet piles. Theoretically, the rotational center of the potential failure plane could be lowered to the tip of the piles. Factor of safety against rotational failure was therefore raised up to as high as 2.07, despite the fact that the undrained shear strength of the soil was lowered to half of what was originally expected due to construction disturbance.

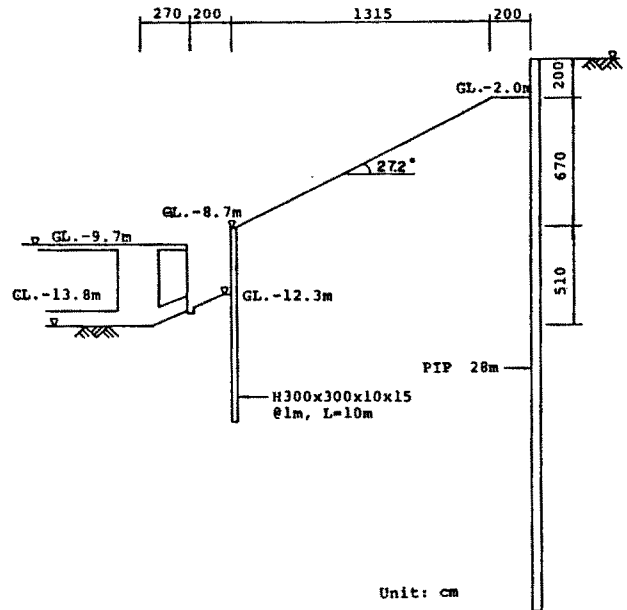
Fig. 4 Retaining Structure during Excavation

At the hotel site, the retaining structure utilizes pre-packed mortar piles. Fig. 4 illustrates the retaining structures used in constructing the central portion of the basement. In order to allow for more construction space, H-pile with laggings were used to support the toe of the berm. During construction, large movement of the retaining structures, sliding of berms and depression of the surroundings occurred. Fig. 5 illustrates the area affected by the excavation of the basement area. From the geometry of the north-east corner slide, one could back-calculate the soil strength to be about 10 kPa. The back-calculated undrained shear strength again was only about half of what was measured from undisturbed samples in the laboratory triaxial testings. The cause of the failure of this slide was therefore attributed to the high sensitivity of the soil.

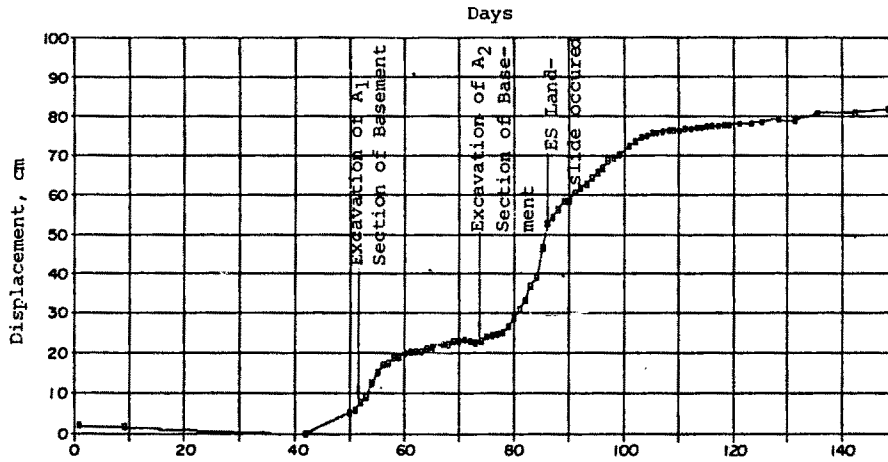
Fig. 6 Displacement at Top of Retaining Structure

The stability of the H-piles also was reviewed using the disturbed soil strength derived from the failure slide. It was found that the active earth pressure acting on the H-piles was significantly higher than the passive earth pressure which the H-piles could derive from the soil at the toe of the berm. Fig. 6 shows the movement of the top

portion of the retaining wall throughout the construction of the basement. It can be found that large movements occurred while central portions of the basement were excavated. The forward leaning of the H-piles also triggered the movement of the berm which abutted on the H-piles. The movement of the berm then in turn caused the forward leaning of the retaining sheet piles.

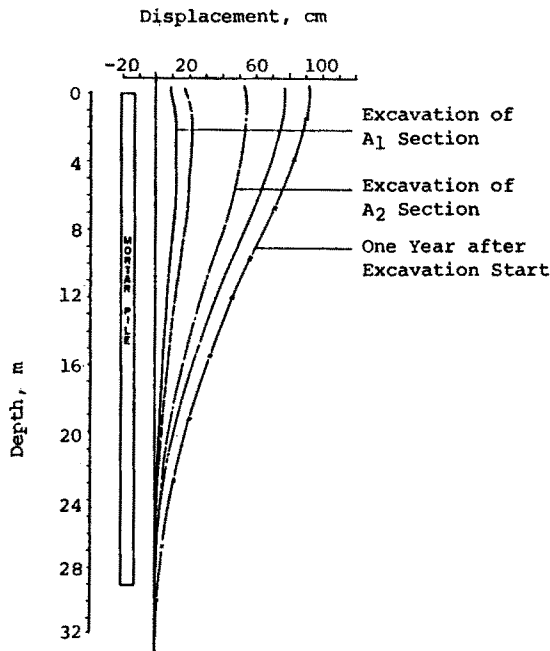
Fig. 7 Deflection of East Side Retaining Structure

Fig. 7 is a summary of the movement of the retaining sheet piles. The forward leaning failure phenomenon is remarkably different from the backward leaning failure observed in the previous case history. Fig. 7 also indicates that significant movement had

occurred while soils in front of the H-piles were removed. Finally, the give-in of the sheet piles had induced depression outside the excavated area. The movement of the H-piles therefore triggered a sequence of failures of the retaining structure.
