# CAISSON FOR SLOPE STABILIZATION

W.S. Guo, L.W. Wong and K.I. Hsiung

*Reprinted from  
Proceedings, 9th Southeast Asian  
Geotechnical Conference, pp. 1-45 - 1-56  
Bangkok, 1987*

W.S. GUO  
*Moh and Associates, Inc.*  
Taipei, R.O.C.

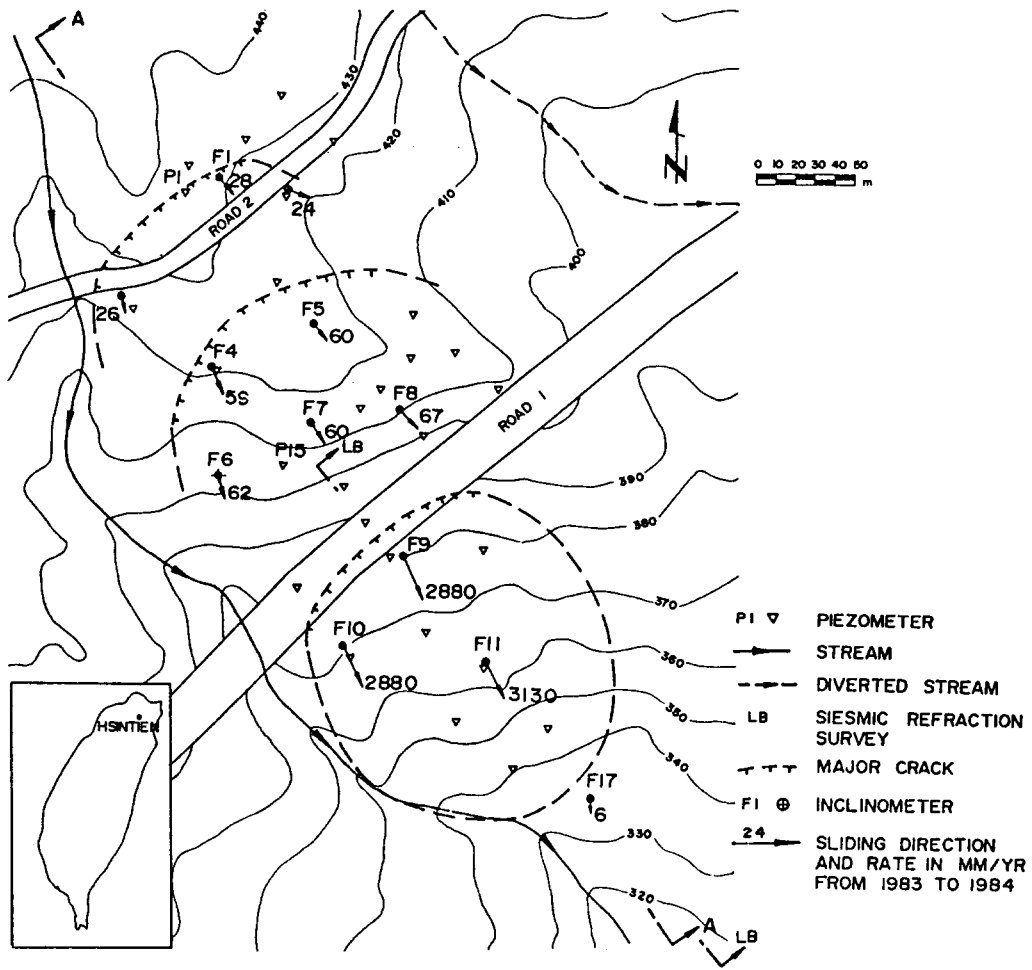
Fig. 1 Site Plan

As shown in Fig. 1, the topography of the site at the time of the study inclined from northwest to southeast with average gradient of about 25°. The elevation of the slope ranged from 300 to 450 m. Three major cracks were observed at the slope. The dimensions of the unstable area were approximately 300 m in length and 150 m in width. A down cutting stream which was the natural drainage outlet of the site was flowing along the southwestern side of the slope.

The rate and the direction of movement of the inclinometer casings are presented in Fig. 1. Differential rates were measured. The toe portion of the slope was moving at an annual rate of 2,900 mm, the middle portion at 60 mm per year and the crown portion at 30 mm per year. The time-displacement plots of the three portions are shown in Fig. 5. The movement observation demonstrates that the colluvial slope has a retrogressive type failure.

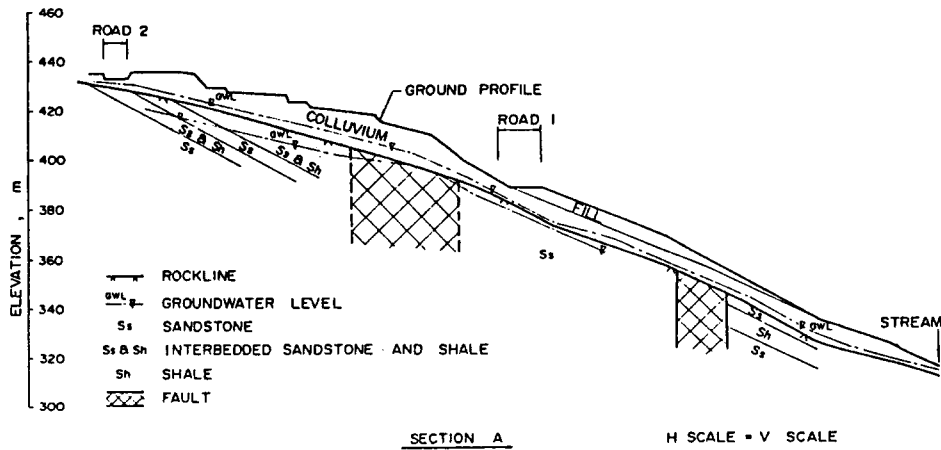
Fig. 2 Geologic Profile

Figure 2 shows the geological section of the slope. The existing upper fault zone in Fig. 2 was inferred from the unconformity with beddings and the extremely fractured cores. It was confirmed at a later stage by direct observation during the excavation of the stabilization works.

distribution of the groundwater table is presented in Fig. 2. The presence of the fractured fault zone obviously affects the groundwater distribution. The piezometric head at the upper fault zone is about 3 m higher than that at other rock strata. Figure 3 shows the piezometric response to rainfall of the colluvial slope, even though there was no rainfall data in February 1985 due to damage to the rain gauge. Both piezometers P1 and P15 were installed at the base of the colluvium. The piezometric levels reached to a peak in the first and second days after rainfall and the dissipation took 5 to 7 days. Piezometer P1 had a higher piezometric response, ranging from 2 to 4 m. The response of piezometer P5 ranged from 1 to 2 m. The amount of piezometric response depends on rainfall intensity, local conditions, and the installation quality of the piezometer.

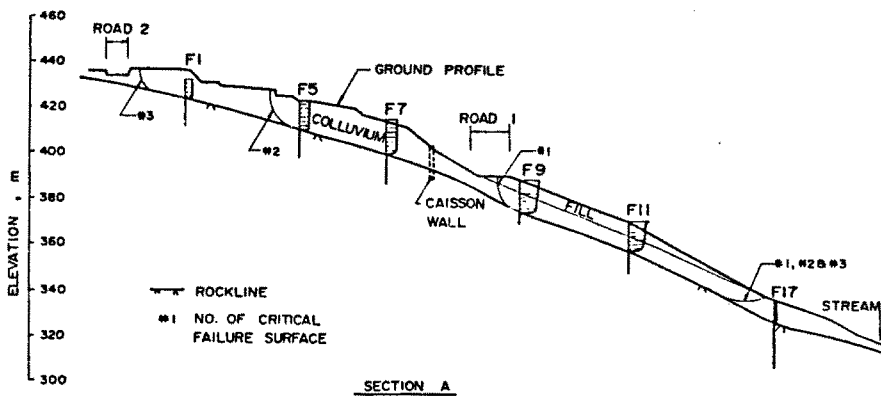
Fig. 4 Failure Pattern of the Slope

Twelve inclinometer casings were installed in order to observe movement of the slope. The depths to the sliding surface were measured before the inclinometer casings were sheared by excessive movement. The position of the failure surface is presented in Fig. 4, indicating the sliding surface coincides with the base of the colluvium. Several piezometers of open tube type were also sheared by excessive ground movement showing the same location of the sliding surface.

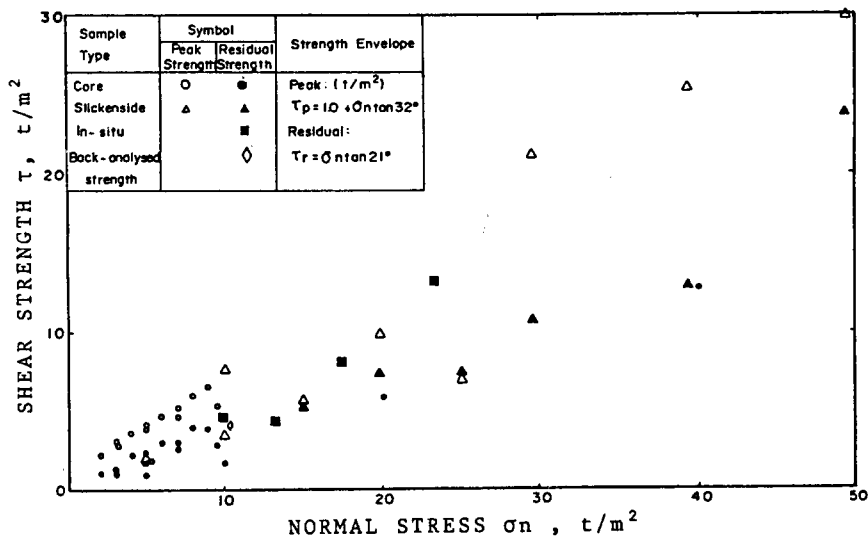
Fig. 7 Direct Shear Test Results of Highly Weathered Shale

The laboratory direct shear tests were carried out by basically following the ASTM-3080 procedure and the in-situ shear box tests followed the ASTM STP 479. The samples were soaked at least for three days prior to shearing. The direct shear test results are shown in Fig. 7. The residual strengths were generally obtained on the third or fourth reversal cycle when the shear strength substantially remained unchanged. Although the results are scattered, the shear strength of the highly weathered shale may be represented by Eqs. (2) and (3).

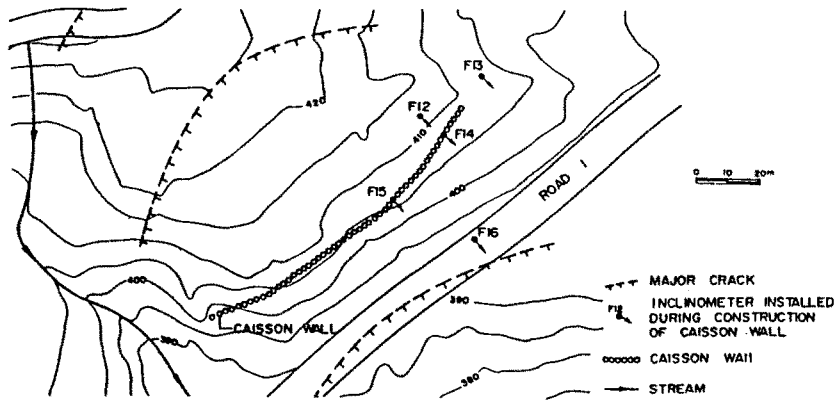
Fig. 8 Stabilization Works for the Slope

A stability analysis indicates that two rows of retaining structures, sited at the middle and at the toe of the slope, are necessary to stabilize the whole area. However, development of the lower portion of the slope would not be carried out in the near future, the extent of the stabilization was then confined to the uphill area of Road 1 only. A single row of caisson wall located in the middle of the slope will suffice the requirements. Figure 8 shows the layout of the caisson wall.

The designed caisson wall comprised 1.2 m diameter caissons, spaced at 2 m center to center, supported by three to four rows of rock anchors with design loads of 75 or 90 t. The caissons were socketed at least 2.5 m into the bedrock. Figure 9 shows a typical section of the retaining structure.

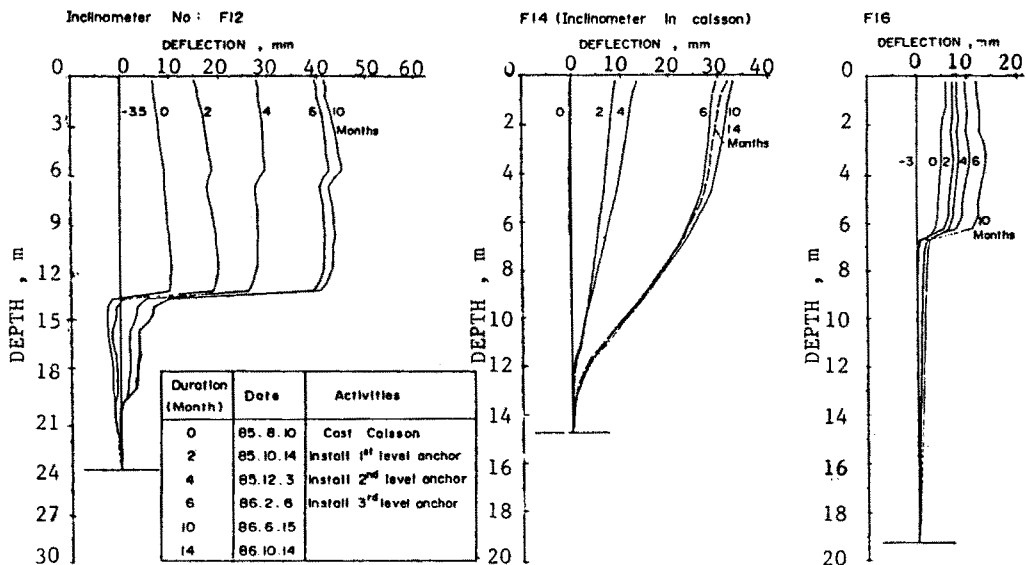
Fig. 10 Movement of Inclinometers Around Caisson Wall

Three additional inclinometers were installed around the retaining structure and another two inclinometers were installed inside two of the caissons. The locations are shown in Figs. 8 and 9, and the observation results are presented in Fig. 10. The results show that the ground behind the caisson wall and the caisson itself moved at a monthly rate of 5 mm prior to the completion of anchor installation. At the post-construction period, the movement rate behind the wall reduced to 0.5 mm/month and virtually there was no movement at the caisson. It can be concluded that the anchor force gradually resisted the sliding pressure and that the slope behind the wall was stabilized.

The ground in front of the wall has continued to move at a rate of 1 mm/month both before and after the completion of the structure. This movement was already expected in the planning stage.

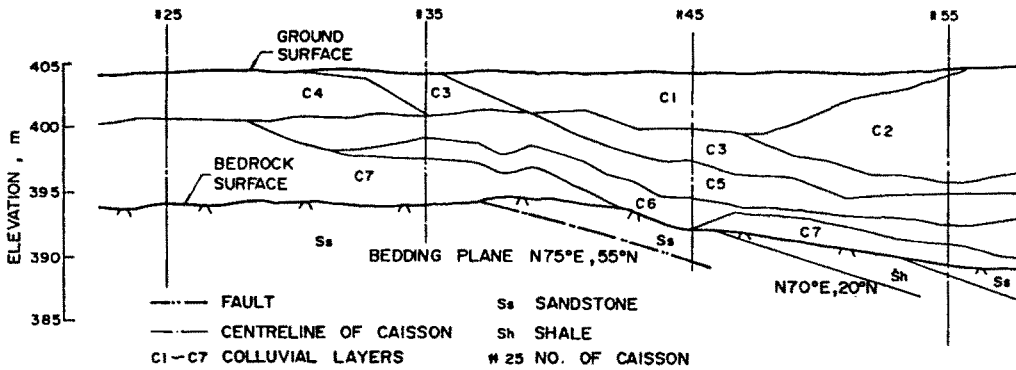
Fig. 11 Profile of Colluvium

is shown in Fig. 11. The profile reveals that the colluvium had deposited in layers with an inclination more or less parallel to the bedrock surface or dip slope. Moreover, a greyish soft shale layer (C6) was encountered near the base of the colluvium. This substantiates that the presence of a weak layer along the base of the colluvium as indicated by stability analysis. Description of the colluvial sub-layer is presented in Table II.
