PREVENTIVE MEASURES OF FOUNDATION FAILURES – CASE STUDIES

by
S. K. Kong

Moh and Associates (S) Pte. Ltd.

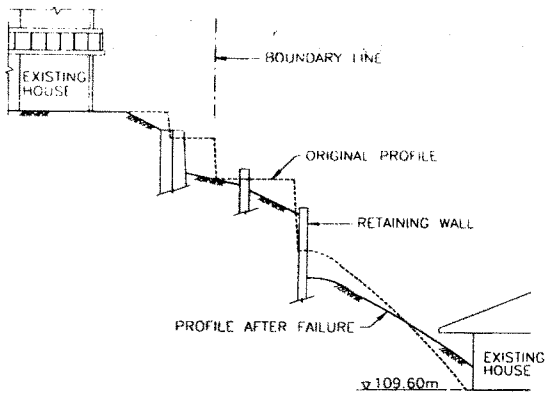
Two (2) earth slopes in the eastern part of Singapore failed during a prolonged rainfall period in 1983 and affected the safety of two (2) residential buildings situated on top of the failed slopes as shown in Figs. 1a & 2a. According to the results of study, both of these two (2) slope failures are found to be attributed to the effect of soil saturation and build-up of porewater pressure in the slope ground resulted from the critical storm weather. In order to minimize further damage to the existing buildings, temporary

Fig. 1a Temporary Stabilisation Work at Site A

stabilisation method consisting of reconfiguration of slope profile and temporary anchors with surface protection was adopted for Site A & Site B as shown in Figs. 1a & 2a, respectively. For permanent stabilisation of these failed slopes, strengthening measures such as permanent ground anchors/retaining walls and protective measures such as gunite surface and horizontal drains/weep holes for preventing surface erosion and build-up of porewater pressure, respectively, have been used as shown in Figs. 1b & 2b.

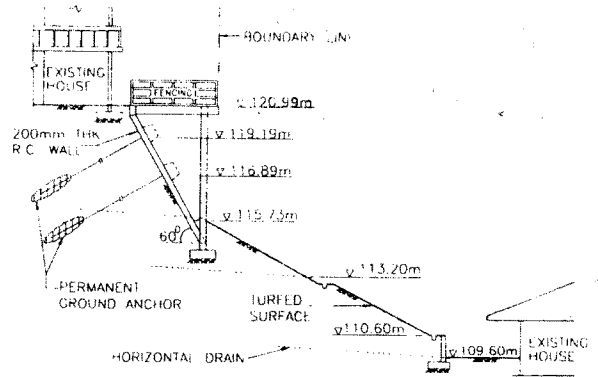
Fig. 1b Permanent Stabilisation Work at Site A

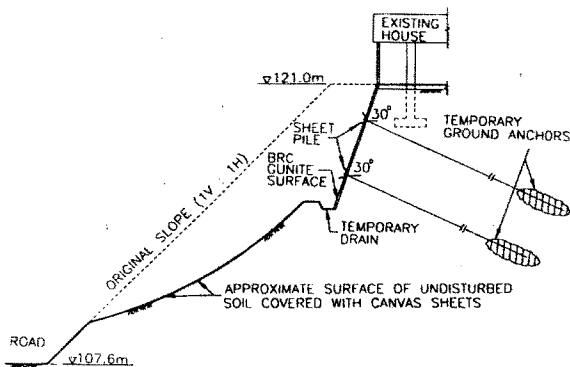
Fig. 2a Temporary Stabilisation Work at Site B

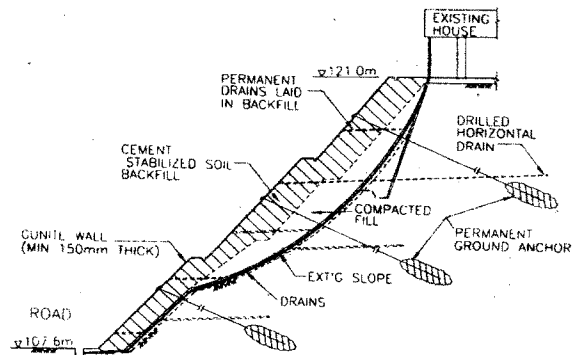
Fig. 2b Permanent Stabilisation Proposal for Site B

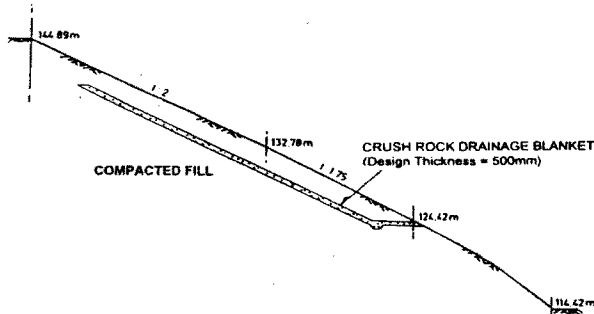
Fig. 3a Details of Drainage Blanket

The original design of the compacted fill slope which supports a series of 2-storey housing on top of the fill has incorporated the installation of a drainage blanket at average depth of 2.5m below the design slope surface (Fig. 3a) for eliminating infiltration effect on the slope stability. According to the design drawing, the drainage blanket consisted of 500mm thick crushed rock enclosed in geotextile filter cloth. However, results of field investigation indicated that the drainage

blanket exposed in the earthslip zone where the drainage outlet was located was found full of fine material and its thickness was far below the design requirement and as a result the functioning condition of the drainage system was affected.

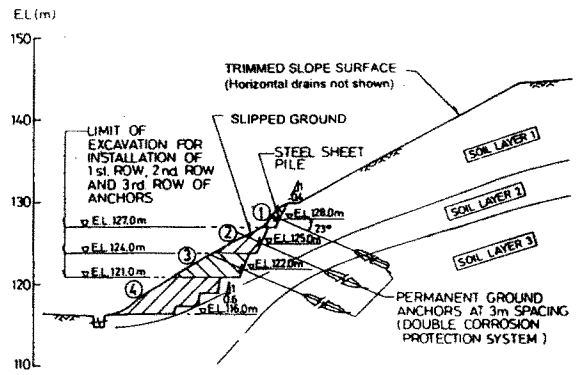
Fig. 3b Permanent Stabilisation to a 28m High Fill Slope (Step 1)

The results of investigation showed that the stability of the fill slope is sensitive to the effect of wetting band which may be created on the existing drainage blanket due to its poor quality as observed in the earthslip zone. The causes of slip failure were concluded to be inadequacy of the existing drainage system (i.e. both the drainage blanket and the surface drains) and the effect of prolonged rainfall. The failed slope was finally restored by using stabilisation measures consisting of i) improvement of existing drainage system using horizontal drains and interceptor drains at mid slope, ii) ground anchor system for temporary and permanent stabilisation at critical slope section, iii) restoration of slipped ground using replacement and compaction method, iv) surface trimming to remove weak soil in the upper slope and v) close turfing to all exposed slope surfaces as shown in Figs 3b and 3c.

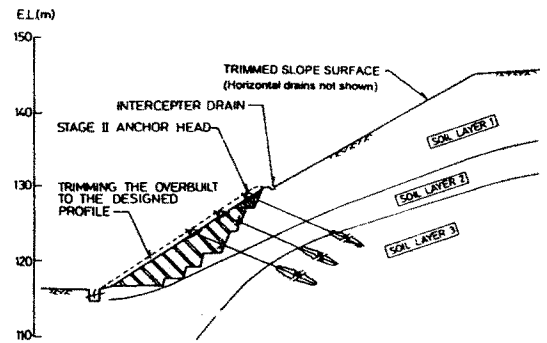
Fig. 3c Permanent Stabilisation to a 28m High Fill Slope (Step 2)

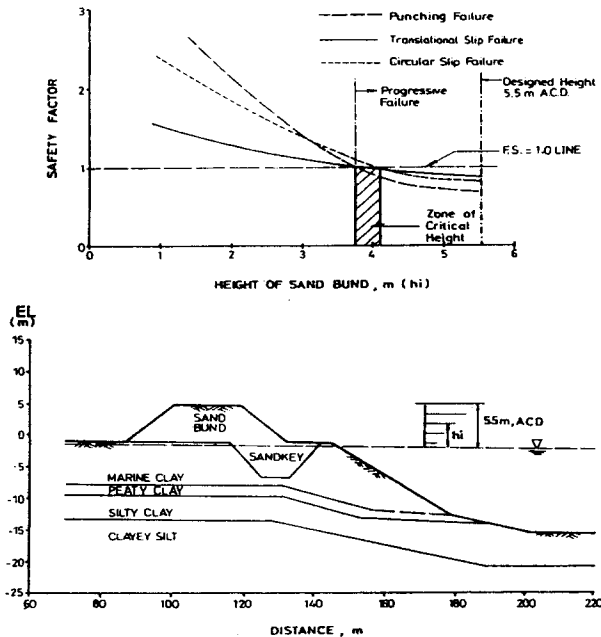
For the reclamation work, the construction consisted of 4 major steps : i.e. i) sand key dredging, ii) filling sand for sand key, iii) bund construction and iii) reclamation, a major slip failure occurred during pumping of the sand to level approaching the designed height (i.e. 5.5m) of the bund. The failure resulted in a volumetric difference of +173,620 cu m (i.e. increase) in the seabed profile and a volume loss of about 3,200 cu m in the sandfill of the newly reclaimed land. The results of stability analysis (Fig. 4) indicated that the design profile of sand bund did not possess adequate factor of safety against punching failure, translational and circular failure due to existence of very soft marine clay/peaty clay found below the sand bund. On the basis of the

measured volume changes and results of analysis as shown in Fig. 4, it is believed that the fill sand has already been transported (i.e. washed and/or progressively slipped) into the sea even before reaching the designed height of sand bund due to existence of the incompetent clay layers.

Fig. 4 Changes of Safety Factor Versus Various Height of Sand Bund

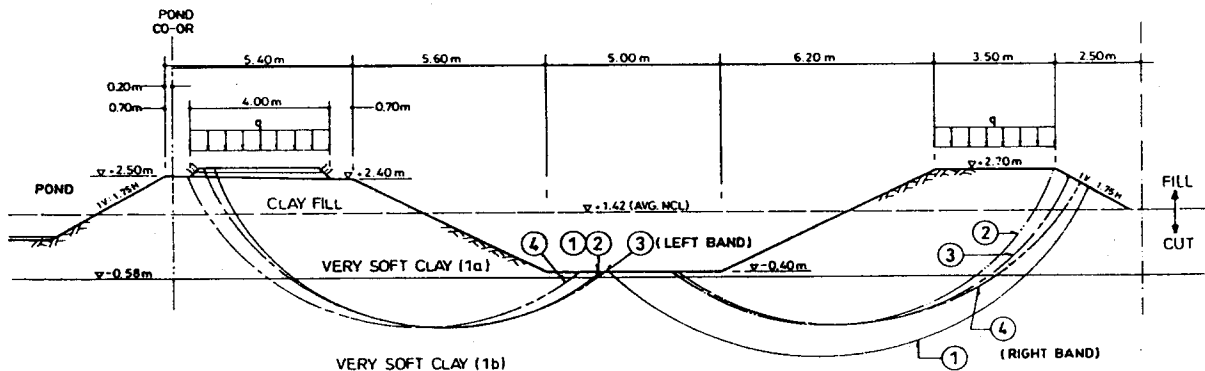
For the Shrimp Framing Project involving the construction of 126 nos. of ponds using cut and fill method, slip failures of embankment were encountered at 15 major locations where very soft unconsolidated marine clay of low shear strength and high compressibility was

found. The embankment with an overall height of 1.5-3.1m were formed by cutting the existing soft marine clay to depth of 0.3-1.9m below the original grade and filling of 0.3-2.1m above original grade using soft clay excavated from the ponds (Fig. 5). Inspection carried out after failure found that deep and wide cracks developed at top and slope surface of the failed embankment. The observed mode of failure showed that the slip failure was likely to be attributable to the development of tension cracks and deep sliding plane through the underlying soft clay due to the inadequate shear strength in supporting the embankment surcharge. This possibility was further verified by the results of stability and bearing capacity analyses which gave low factor of safety values of less than 1.0 (Table 1).

Fig. 5 Typical Profile and Stability of Embankment

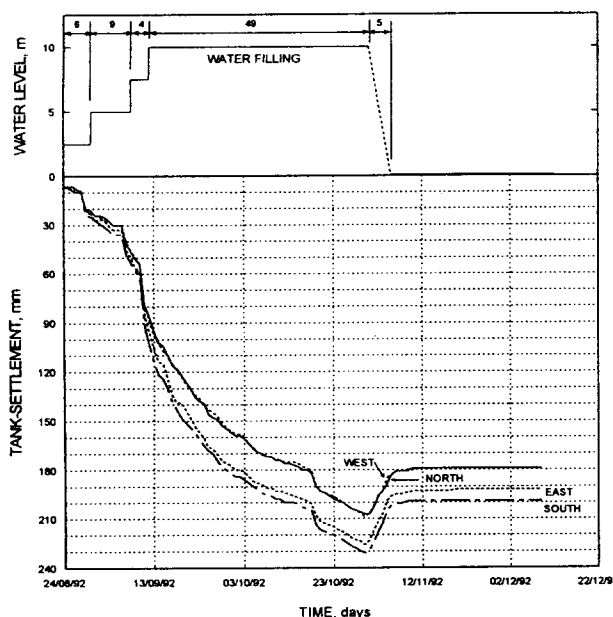
Two each of 11.3m and 6.2m diameter steel tanks constructed on shallow foundation failed the hydro-testing due to excessive settlement, tilt and suspected base plate deformation. Fig. 6 shows the time-settlement curve of one of the tank (TK-3A) prepared based on the record of hydro-test. Results of cause study on excessive settlement experienced by the four tanks found that the failures were attributed to the existence of soft organic clay/marine clay which were encountered below a 3m thick fill layer and extended to a depth of 12m below the tank base. The analysis of tank settlement (Table 2) showed that the observed settlement were within the expected final settlements of the four tanks founded on shallow foundation. Therefore, the excessive settlement of tanks could be avoided if proper assessment on tank settlement and application of soil improvement technique were considered in the tank foundation design.

Fig. 6 Time-Settlement of Tank No. 3A under Hydro-Test
