PIPING FAILURE OF A COFFERDAM IN SOUTHERN TAIWAN

*Reprinted from Proceedings of International Conference on
Foundation Failures
May 12~13, 1997, Singapore, pp.209~216*

Moh and Associates, Inc., Taiwan, ROC

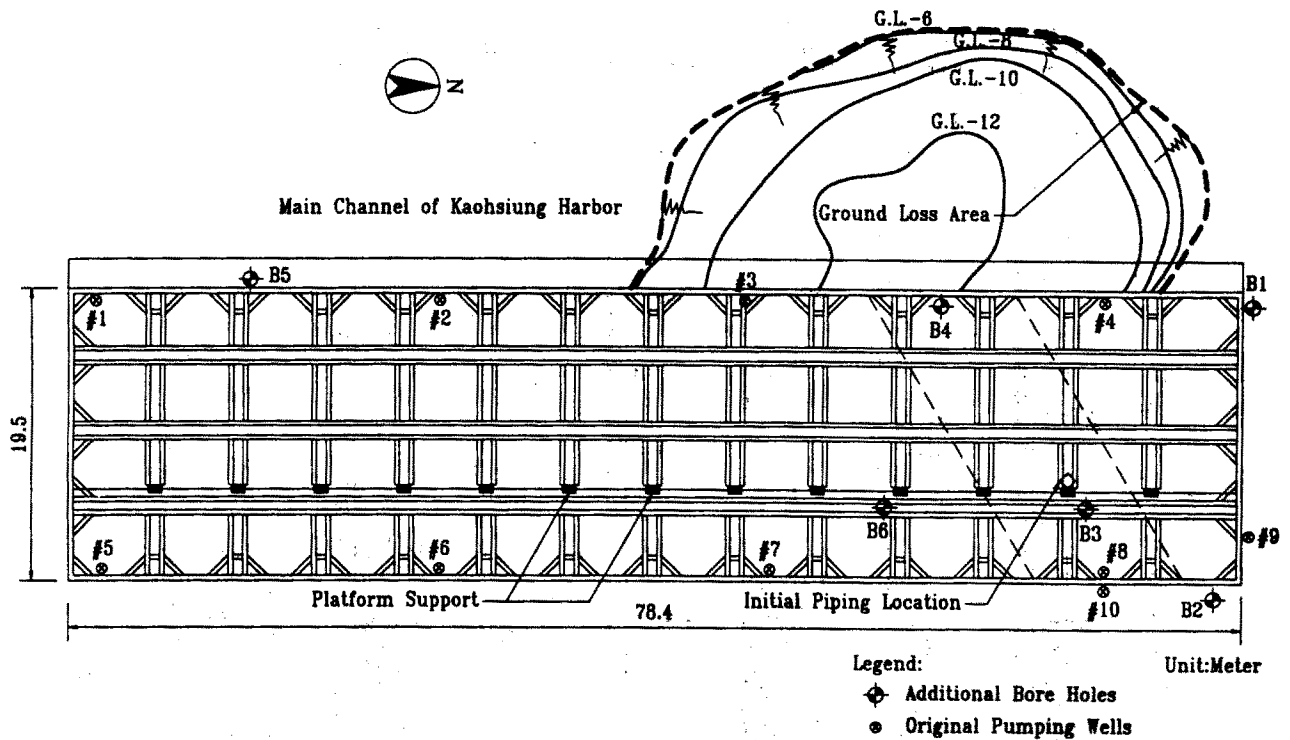
Fig. 3. Extent of sinkhole and locations of additional boreholes

The excavation had already been completed prior to the incident. Based on field records, water started to run at a location, refer to Fig. 3, near a platform support shortly after a typhoon

A reconnaissance was made in the following morning. A 44-m section of the west pier was found to have collapsed and more than 3000m³ of sand had intruded into the excavation piling to a maximum height of 3.8m above the bottom. Sounding revealed a large sinkhole outside the pier as shown in Fig. 3. Fortunately, no one was hurt and there was no structural damage to the retaining system or to the adjacent factory. All the instruments were still functional and the readings were within the pre-set tolerances.

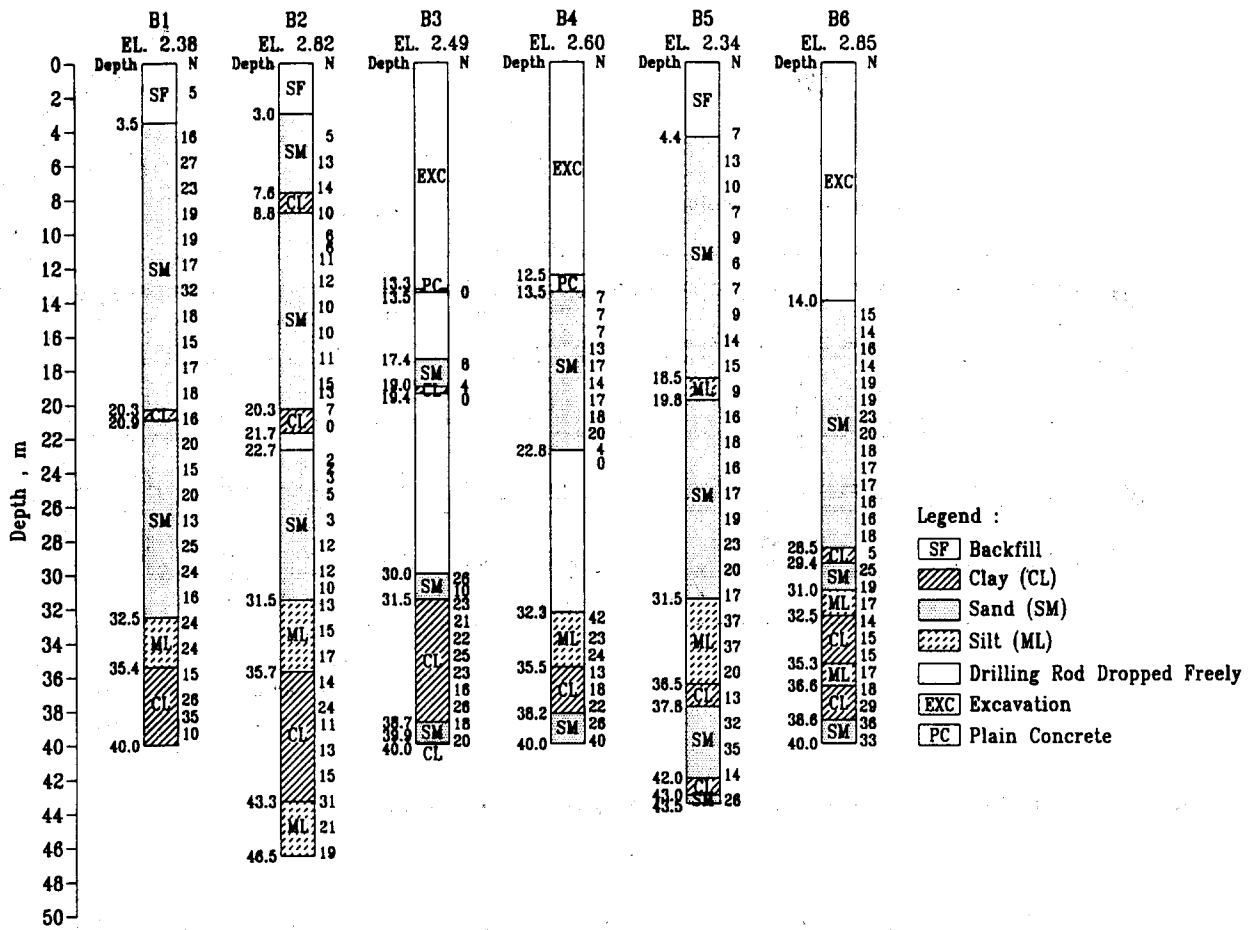
Fig. 4. Boring logs

SPT N-values were zero at some depths in Boreholes B2, B3 and B4, indicating that the subsoils were seriously disturbed. A schematic view of the failure is given in Fig. 5.

In Borehole B4, which is the nearest to the center of the sinkhole, there appeared to be a 0.3m section of disturbed zone below the bottom of the SMW, the toe of which was at a depth of 32m. This indicates that a tunnel had been formed and become a water path leading to the failure. Since this borehole is not necessarily right at the middle of the course, it is conceivable that the size of the tunnel could be much larger, say, of an order of 1m to 2m.

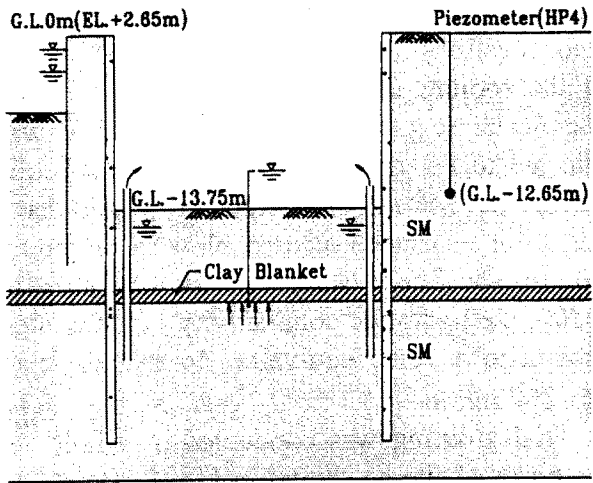
Fig. 6 Water head below the clay blanket

Fig. 6, in the upper region, water was free to flow into the wells by gravity. The lower region was concealed at the top by the clay blanket and was pressurized by the seepage flow from the bottom. The pressures were released at wells on the two sides. It is not difficult to realize that the water head at the mid-section was greater than the water heads near the walls.

Two-dimensional finite element seepage analyses showed that, although the water levels in the wells were maintained at a level of 2m below the bottom of excavation, the pressures acting on the underside of the clay blanket would be of an order of 100 kPa at the mid-section. The weight of soil above the blanket was roughly 114 kPa for a unit weight of 19 kN/m³ and a thickness of 6m (i.e., 19.5m-13.5m). Therefore, the factor of safety against blow-in at mid-section is very marginal. In fact, the problem is three dimensional, rather than two-dimensional. The wells were point sinks rather than drainage trenches as implied in the two-dimensional analyses. The pressures at the two ends and at the center of the pit would have been much greater than what was computed. Bauer *et al.* (1980) had emphasized such a phenomenon which should properly be considered during the design of cofferdams.

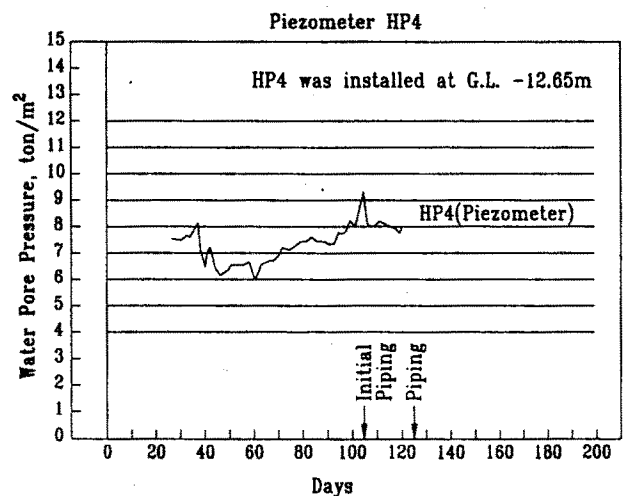
Fig. 7. Ground water levels

The problem was aggravated by the waves and the heavy rain accompanying the typhoon. It is conceivable that the waves would be a meter or two above the high tides which were the basis of design. The readings of Piezometer HP4, the location of which is shown in Fig. 1, installed in the compartment bound by SMW and sheet piles to the north of the excavation are shown in Fig. 7. As can be noted, the water level was 1m higher than the previous elevation before piping first occurred. Unfortunately, HP4 was installed above the clay blanket (at G.L. -12.65m) and the readings do not represent the water head in the lower region. It is even more pitiful that there were no piezometers available inside the pit. It is quite possible that the pressures acting on the underside of the clay blanket increased as the groundwater level rose. It is also possible that the pumps were incapable of coping with the additional surface water during the heavy rain and the water levels in the wells could no longer be maintained at the desired level (i.e., 2m below the bottom of excavation).

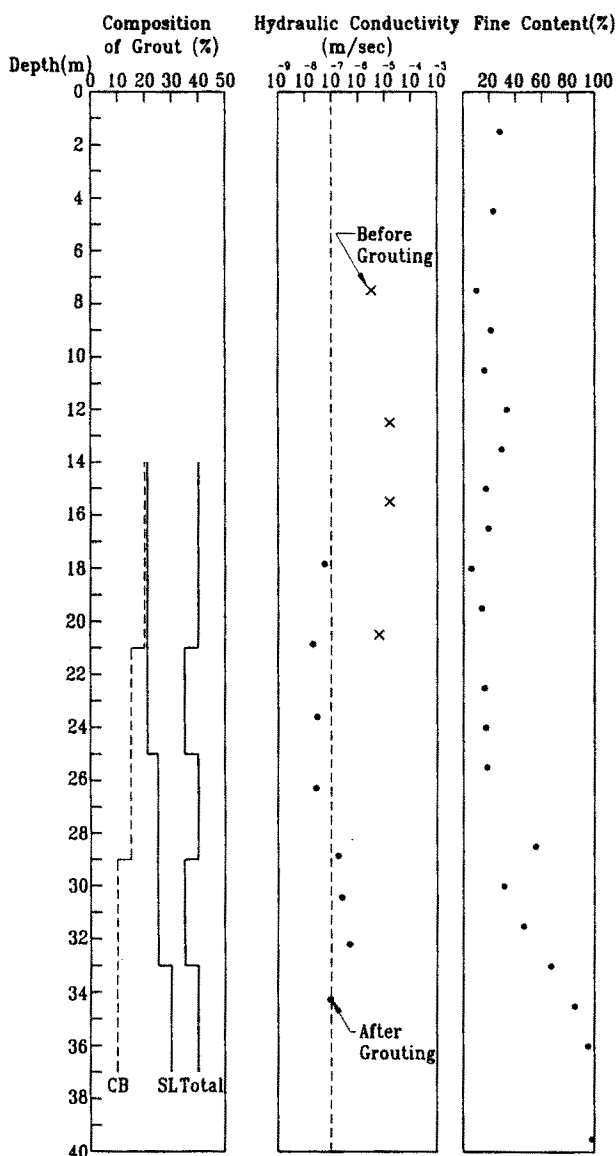
Fig. 9 Hydraulic conductivity, quantities of grout injected and fine contents of soil

A total of 1,317m³ of grout was injected in these 28 holes. Hole A17 alone took 292m³ while the three neighboring holes, A13, A19 and A20, took 86m³, 83m³ and 85m³ respectively, although they were grouted prior to A17. It is therefore evident that Location A17 must be where piping was the initiated

A total of 31 in-situ tests were performed and the average of the hydraulic conductivities obtained was $(4.6 \pm 3.0) \times 10^{-8}$ m/sec. In two holes, where the grouting pressures did not reach 0.3 MPa, the values obtained were of the order of 1.3×10^{-7} m/sec which was slightly greater than the design criteria of 1.0×10^{-7} m/sec. Additional chemical grout was injected locally and the hydraulic conductivity was reduced to 3.2×10^{-8} m/sec.

Grouting was carried out in 50 holes in the failure zone, and 100 holes along the west side. The locations of these grouting holes are shown in Fig. 8. A fixed quantity of grout was injected at each depth at a rate of 10 liters per minute using the double-packer grouting method. In each hole, grouting was conducted in two steps as follows:
