**A SMALL HOLE
COULD BECOME REALLY BIG**

Z. C. Moh, D. H. Ju, and R. N. Hwang

A Small Hole Could Become Really Big

Momentous Lecture - 14th International Conference on Soil
Mechanics and Foundation Engineering,
6 - 12 September 1997, Hamburg, Germany

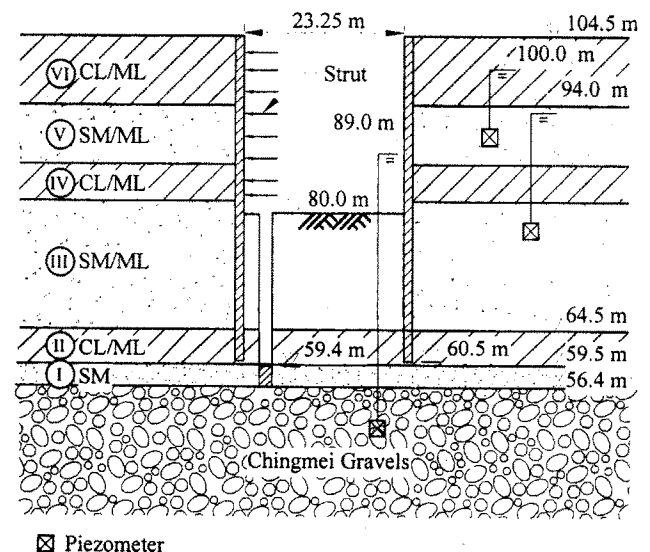
exists a thick layer of young sediments, i.e., the so-called Sungshan Formation, from the ground surface to a depth of 48m. The Sungshan Formation comprises 6 sublayers of which Sublayers I, III and V are composed of silty sands (SM/ML) and Sublayers II, IV and VI are composed of silty clays (CL/ML). Underneath the Sungshan Formation is a gravelly layer, i.e., the so-called Chingmei Gravels. The Chingmei Gravels was in an artesian condition decades ago and was the sole source of water supply for the City of Taipei for nearly half a century. In the mid-70's, the piezometric level in the Chingmei Gravels dropped to, as low as, RL 60m as a result of excessive pumping. It

Fig. 1 Soil profile and configuration of excavation

The excavation of interest was for constructing an underground station of the Taipei Rapid Transit Systems. As shown in Fig. 1, it was 23m in width and was carried out to a depth of 24.5m by using the bottom-up method. The pit was retained by diaphragm walls, 1.2m in thickness and 44m in length, and braced by 8 levels of temporary struts. The diaphragm walls toed in Sublayer II to provide a seepage cutoff. Sublayer II, which is an impervious layer consisting mainly of silty clay, essentially served as a seal at the bottom of soil plug which was enclosed by diaphragm walls on its four sides. With a length of soil plug of 20.5m, a factor of safety of 1.3 was obtained against blow-in for a piezometric head of 29.5m at the bottom of the plug. At the time when the incident occurred, the bottom of excavation had been reached and, except at the southern end where the incident occurred, base slab had already been cast.

The incident obviously started as the soil at the bottom of the borehole liquefied. As illustrated in Fig. 1, the tip of borehole was entering Sublayer I at the time when water started to overflow. The Chingmei Gravels is extremely permeable. The fine particles in Sublayers I and II were carried away by the fast moving water at the contact with the Chingmei Gravels. At first, water paths would propagate laterally in Sublayer I which is more susceptible to erosion than Sublayer II and the Chingmei Gravels. As Sublayer II caved in, its integrity as a clay blanket was destroyed and the water paths would propagate upward into Sublayer III which had a higher piezometric level than the Chingmei Gravels. These water paths would spread in all directions and connect each other to form large cavities. As arching effects were no longer able to hold up the ground, the roof above these cavities collapsed and ground settlements followed. The scenario shown in Fig. 3 and the extent of disturbance to the ground were confirmed by the subsequent investigations following the incident.

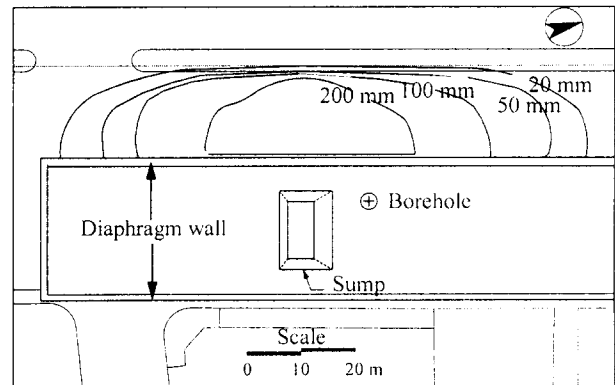
Fig.2 Site plan and settlement contour

As shown in Fig. 2, the 20mm contour of ground settlement extended to a maximum distance of 60m away from where the borehole was. Ground settlements, as shown in Fig. 3, however, were confined by an existing underground structure, which had deep diaphragm walls as retaining structures when it was constructed, and did not go too far toward the west. The maximum ground settlement was estimated to exceed 250mm.

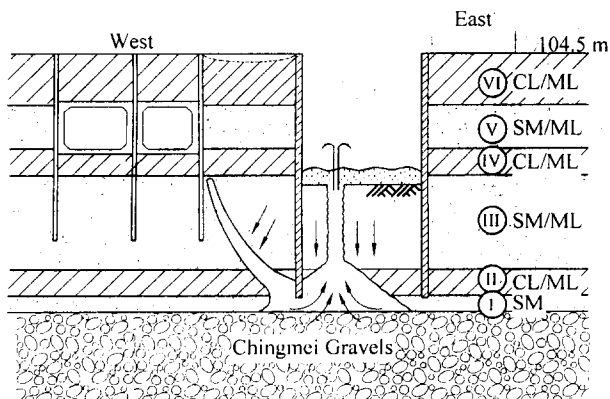
Fig. 3 Scenario of the incident

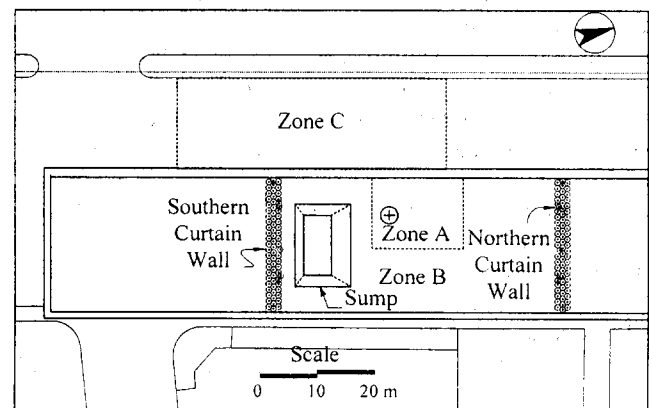
Fig. 4 Curtain walls and zones for compensation grouting

The area affected was divided into Zones A, B and C as depicted in Fig. 4. Compensation grouting started in Zone C in the day following the incident in order for the street to be open to traffic as soon as possible. A total of 2,230 cubic meters of LW grout, with a consumption of 850 tonnes of cement and 223 cubic meters of sodium silicate, was injected in 68 holes. Most of the grout was taken between RL 60m and RL 84m. Grouting continued till a pressure of 300 kPa was reached without specifying the quantity of grout to be taken in each hole. Ground heaved up by, on an average, 33mm. At a few locations, heaves up to 80mm were observed. The heave, in a sense, was an indication that cavities were satisfactorily filled.

Two curtain walls were installed, one at the northern and the other at the southern end of Zone B, to confine the grout to within the disturbed zone. As shown in Fig. 5, these curtain walls extended to a level of RL 65m. A total of 800 cubic meters of LW grout, with a consumption of 200 tonnes of cement and 200 cubic meters of sodium silicate, was injected in 60 holes for forming the southern wall and in 63 holes for forming the northern wall. In each hole, the take was limited to 220 liters per meter or till a maximum pressure of 800 kPa was reached, whichever occurred first. The pin piles supporting the struts heaved up by, on an average, 10 mm or so and the sequence of grouting had to be adjusted to minimize heaves. The maximum heave of pin piles observed was 38mm.

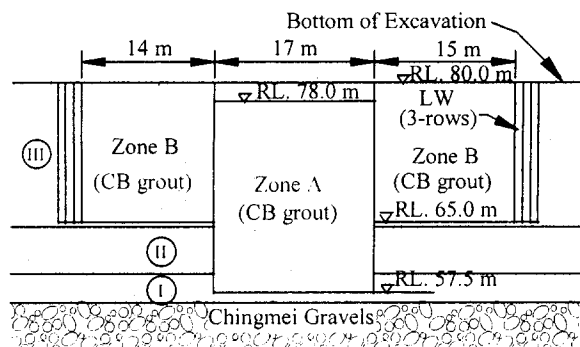
Fig. 5 Section for curtain walls and compensation grouting

Grouting in Zone B was carried out in 117 holes to, as shown in Fig. 5, the same depth as the curtain walls, i.e., RL 65m using the double-packer technique. Grouting continued till a take of 1,000 liters per meter or a pressure of 800 kPa was reached, whichever occurred first. A total of 1,580 cubic meters of cement-bentonite grout, with a consumption of 630 tonnes of cement and 71 tonnes of bentonite, was injected. The heaves of pin piles were in general less than 10mm with a maximum of 16mm.

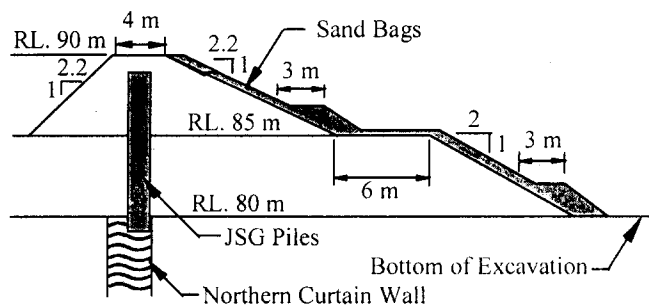
Fig. 6 Cross-section of dike

As mentioned previously, at the time when the incident occurred, excavation had reached the bottom and, except at the south end, base slab had been cast. Because the remedy of the southern end would be time consuming, in order for the works in the remaining section to resume as quickly as possible, a dike was constructed to separate the pond into two. It was constructed right above the northern curtain wall using the sand and gravels previously dumped as the embankment. The embankment was trimmed to the configuration shown in Fig. 6. The curtain wall was extended by high pressure jet grouting to form an impervious core for cutting off seepage through the dike. The gaps between the grout columns and the diaphragm walls were sealed by LW grout.

The dike also served as a contingency in case the soil

plug was not fully mended and a similar problem occurred for the second time. In such a case, the southern pond was able to be filled up quickly while the works to the north of the dike could still continue. Fortunately, the compensation grouting was successful and problem did not occur in the subsequent operations.
