A CASE STUDY OF PIPING FAILURE ASSOCIATED WITH SHIELD TUNNELLING

L.S. Lin, D.H. Ju and R.N. Hwang

*Proceedings of 15th International No-Dig '97, Taipei, Taiwan
November 26~28, 1997, pp.6B-1-1~6B-1-13*

SYNOPSIS: Making openings on diaphragm walls or base slabs is always a risky operation when the ground is permeable and water table is high. In 1995, piping failure occurred during the opening of one of the tunnel portals at an arriving shaft of the Panchiao Line in the Initial Network of the Taipei Rapid Transit Systems. It created a sinkhole of as deep as 6m and caused serious damages to adjacent structures and unacceptable distortions of tunnel segments. As a result, the construction was delayed by two years and the financial loss was tremendous.

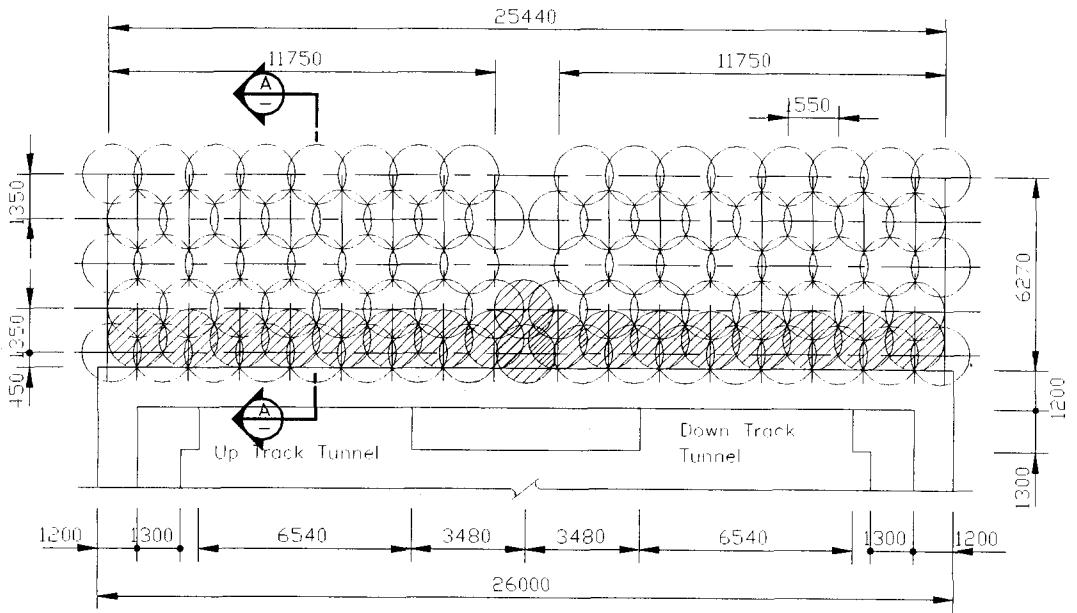
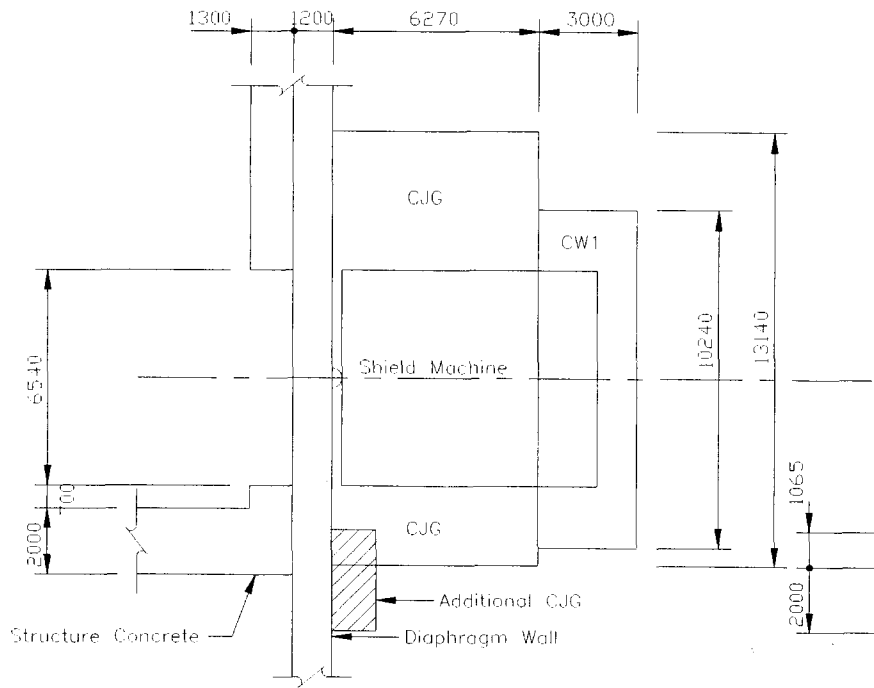
Fig.3 Ground Treatment

To prepare for the arrival of the shield machines, Column Jet Grouting (CJG) was conducted to harden the soil at the portals to form two protective tubular shelters for the shield machines to stay temporarily to wait for the opening of the portals. A total of 40 grout columns, 1.8m in diameter, were installed at each of the two portals by injecting mixture of cement-water at high pressure using the triple-tube technique. They were spaced at 1.35 to 1.55m apart, center to center, as shown in Fig. 3.

The treated ground was initially 6.27m in length and was lengthened by 3m using chemical

grouting (CW1) to fully cover the entire shield machines which were 7.68m in length. Tests indicated a permeability of 5×10^{-6} cm/sec of the treated ground. Before the diaphragm wall was knocked out to make the opening, horizontal holes were made through the diaphragm wall into the treated ground to check if leakage would occur. A total of 67 holes were made on the two portals and they penetrated into the treated ground for, upto, 3.1m. Minor leakage did occur and was stopped by injecting OH and LW solutions. To further ensure the safety of construction, 18 additional CJG columns were installed, refer to Fig. 3, right at the back of the diaphragm wall. After the shield machine entered the shelter, CW1 and Set Foam were injected from the inside of the shield in an attempt to fill the fissures, if any, in the treated ground.

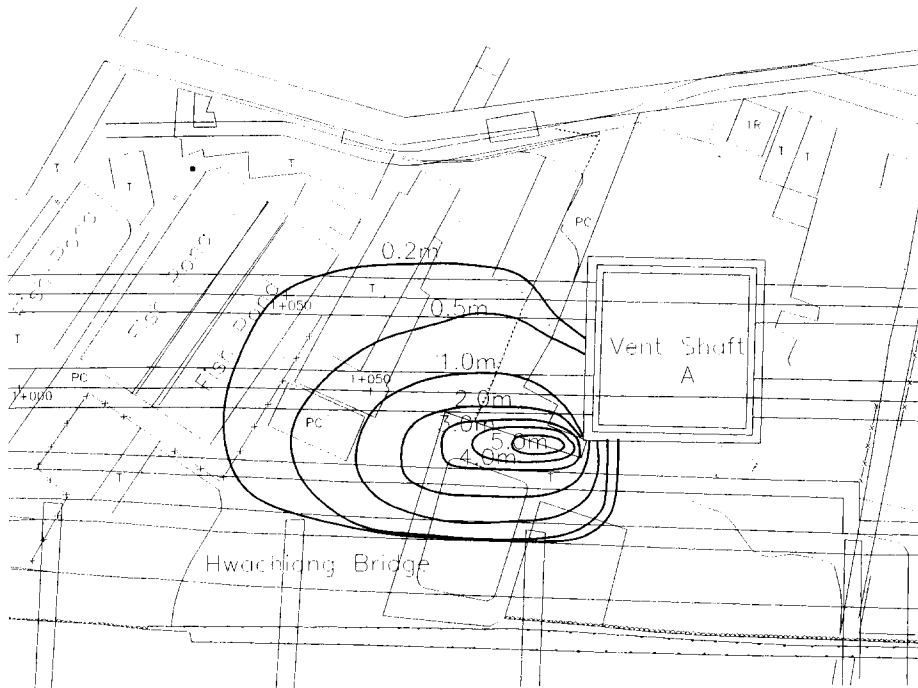
Fig.4 Settlement Contour

At 01:30 of July 16, 1995, an inflow of water, with an estimated rate of 200 m³/hr, was observed at the invert when the diaphragm wall was knocked out to prepare the portal for receiving the shield machine in the Up-Track tunnel. Sand bags were placed in front of the portal in an attempt to stop the flow in vein. Set Foam was injected and grouting was applied from the inside of the shield in an attempt to seal off the hole, but this did not lead to any improvement of the situation. Within hours, the flow increased to a rate of 500 m³/hr and a large quantity of soil was washed into the shaft. The water appeared to have come from the Chingmei Formation which is practically an underground reservoir. The bolts on segments started to burst and the segments started to deform. Much water entered the tunnel from cracks on segments and rushed to the shaft. The situation was judged to be dangerous, the efforts of stopping the water were abandoned and all the workers were ordered to retreat to the surface at 04:00. The ground behind the diaphragm wall finally collapsed resulting in a sinkhole, with a maximum depth of 6m, right above the shield machine. Ground settlements extended to a distance of 70m from the shaft as shown in the contour in Fig. 4.

The safety of Hwachiang Bridge, of which the nearest pier (refer to Fig. 4 for location) is only about 15m away from the center of the sinkhole, was a major concern to everyone. Fortunately, instrument readings indicated that the bridge was unaffected. The piers were founded in the Chingmei Formation which is difficult to be eroded. The shops to the west of the shaft, however, settled by a maximum of 320mm. They were judged to be unsafe for business and had to be closed. Cracks occurred on the slabs of fish ponds, which were used for fishing as a recreation, inside these shops and water in these ponds was completely gone. The shop owners were compensated for the shops, ponds, the fish killed, and the loss of revenue. These shops were finally demolished and rebuilt.

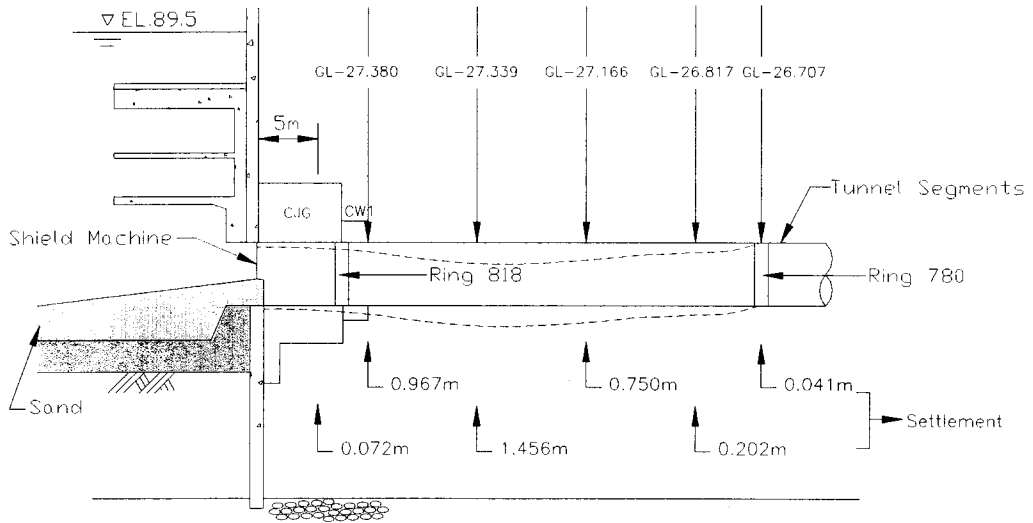
Fig.6 Settlements of the Up -Track Tunnel

The settlements of the tunnels were estimated by checking the elevations of the tunnel crowns by drilling to reach the crown. The maximum settlement of the tunnel was found to be 1.46m for the Up-Track tunnel and a total of 39 rings (Ring Nos. 780 to 818) were found to have settled. Fig. 6 illustrates the distortion of the Up-Track tunnel. For information, the last segment in the Up-Track tunnel was Ring No. 818 which was still inside the shield.
