SOFT GROUND TUNNELING IN TAIPEI - PROBLEMS AND SOLUTIONS

Z. C. Moh, J. L. Chang and R. N. Hwang

*Reprinted from Proceedings of
Dr. Tan Swan Beng Memorial Symposium,
Excellence in Infrastructure Engineering
March 18~19, 1999, Singapore, pp.87~97*

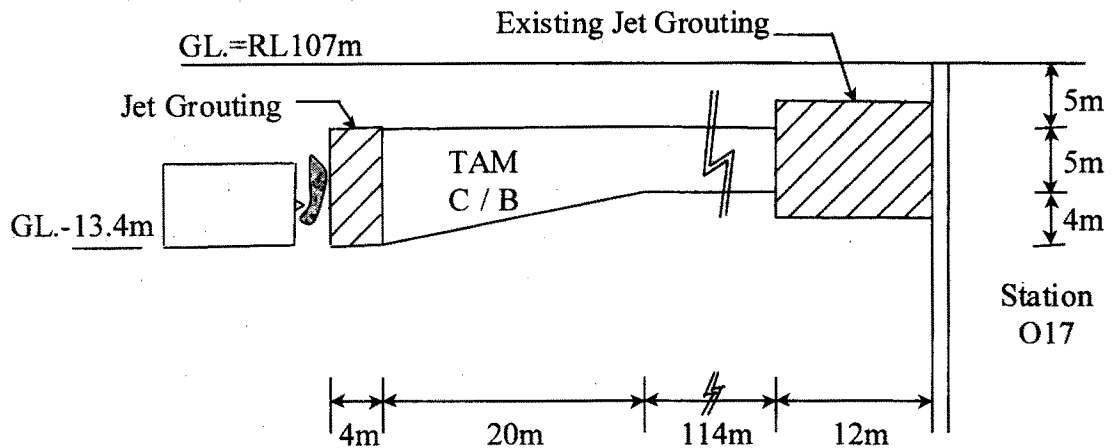
Figure 5 Ground Treatment at Up-Track Tunnel of Contract CC277

Large tree trunks, up to 1.5m in diameter and 5m in length, were often encountered, usually at depths of 10m to 20m, during excavations for constructing basements and TRTS stations [7]. Pieces of wood were frequently removed from the spoil during tunneling, however, very few major problems were reported except that conveyors or pumps were sometimes jammed. A large tree trunk nevertheless did stop the shield machine during driving of the Up-Track tunnel of Contract CC277 of the Chungho Line. It was reported that the daily progress of tunneling was reduced from 43 rings

(1m per ring) on 14 June, to 10 rings on 15 June, and to 4 rings on 18 June, 1996. Chunks of wood were observed for many times at the conveyor during this period. In the morning of 19 June, the machine was totally stuck during the driving of Ring 696 and a sinkhole of 3m in depth and 36 cubic meters in volume was found at surface right in front of the shield. It appears that a tree trunk had been pushed by the shield machine for 14m or so. Jet grouting, refer to Figure 5, was carried out in front of the shield for maintaining the face stability to allow workers to enter the earth chamber to free the cutter [8]. Two pieces of drift wood, with dimensions of 500mm x 200mm x 150mm and 400mm x 200mm x 140mm, were recovered in the earth chamber. For the remaining tunneling work to be carried out safely, the ground was treated by cement-bentonite grout using the TAM method. Wood fragments were washed out from several holes drilled for grouting. More tree trunks were found during the subsequent tunneling, particular in the section between Ring 715 and Ring 721. However, these tree trunks were clamped by the treated ground and were able to be scraped away by the advancing tunneling machine.

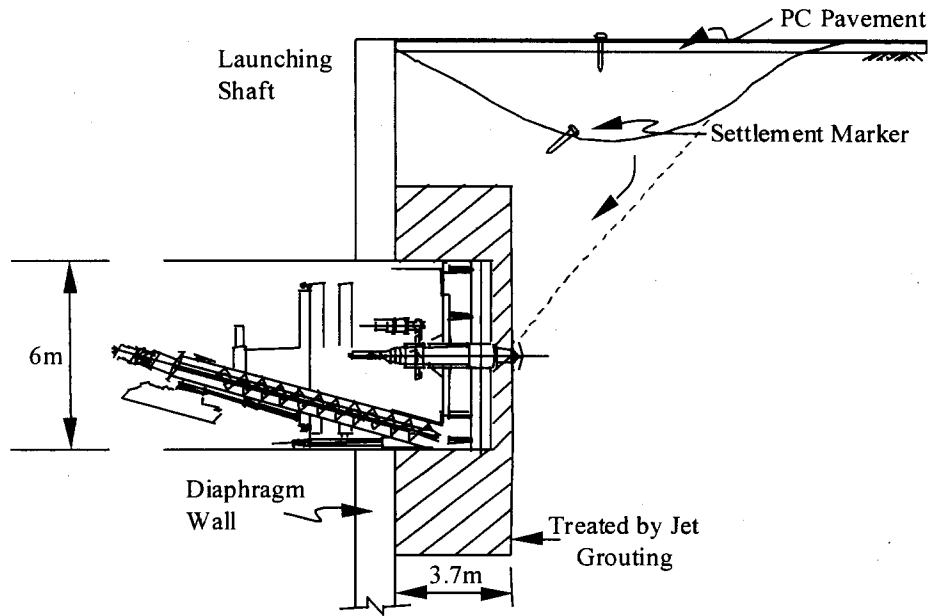
Figure 6 Tunneling Problem during Launching in Contract CT201A

Figure 6 shows a situation encountered during tunneling in constructing the Tamshuei Line. A sinkhole of roughly 3m in depth and 75 m³ in volume was found in front of the shield machine as the specialist subcontractor looked for a missing settlement rod installed for monitoring ground settlement. The cavity was covered by the RC pavement which did not show any signs of subsidence. In this case, jet grouting had been used to treat the ground at the back of the diaphragm wall to prepare for launching of the shield. Because the treated ground was too hard, driving of the shield was difficult since the very beginning and chemical had to be injected into the earth chamber as lubricant. Even so, worker had to go into the earth chamber to free the cutter from time to time. It was reported that the temperature of the spoil in the earth chamber was as much as 60°C. It is postulated that, as the cutter reached the end of the treated zone, a mixed-face situation was encountered. As most of the tunnel face was still in the treated ground, the shield advanced rather slowly. On the other hand, portion of the face was already in the natural ground and soil could easily be excavated and “sucked” into the earth chamber. From what was observed and experience learned elsewhere, it may be concluded that if the treated ground has an unconfined compressive strength of 40 MPa or above, shield driving is likely to encounter difficulties. This, however, certainly will depend on the capacity of the machine used. To avoid similar events from happening, it may be a good idea to have a transition zone with weaker strength at the end of the ground treated by jet grouting.

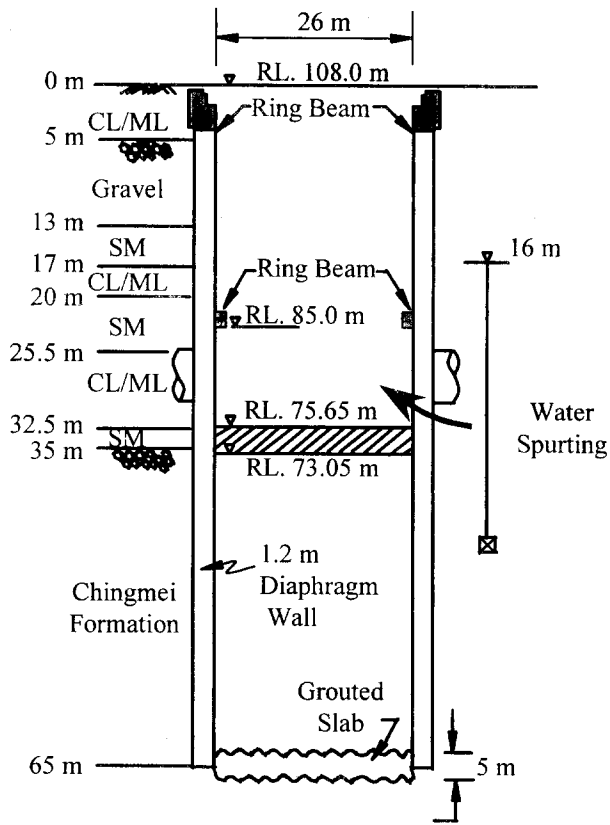
Figure 7 Grouted Plug at Ventilation Shaft in Contract CH221

There were a few major ground collapses which occurred either during launching from shafts or during arriving of shield machines at shafts. Although ground treatment is routinely carried out behind diaphragm walls, there is no way to ensure that treatment is uniform and the treated ground is perfectly watertight. The Chingmei Gravels is extremely permeable and is very rich in water. Therefore, if the opening made on diaphragm wall is too close to the Chingmei Gravels, once leakage occurred, soil surrounding the water path quickly liquefied and the flow usually became uncontrollable in hours. In the case shown in Figure 7, when the tunnel portal was enlarged for installing the flexible joint, ground subsided by several meters and a section of tunnel collapsed. As a result, 23 rings were seriously damaged and had to be replaced. Ground freezing was used to form a patching pad to seal off the portal for the shaft to be drained and cleaned. Subsequently, ground freezing was used again to form a shelter to surround the section of tunnel which was damaged for segments to be replaced [4].

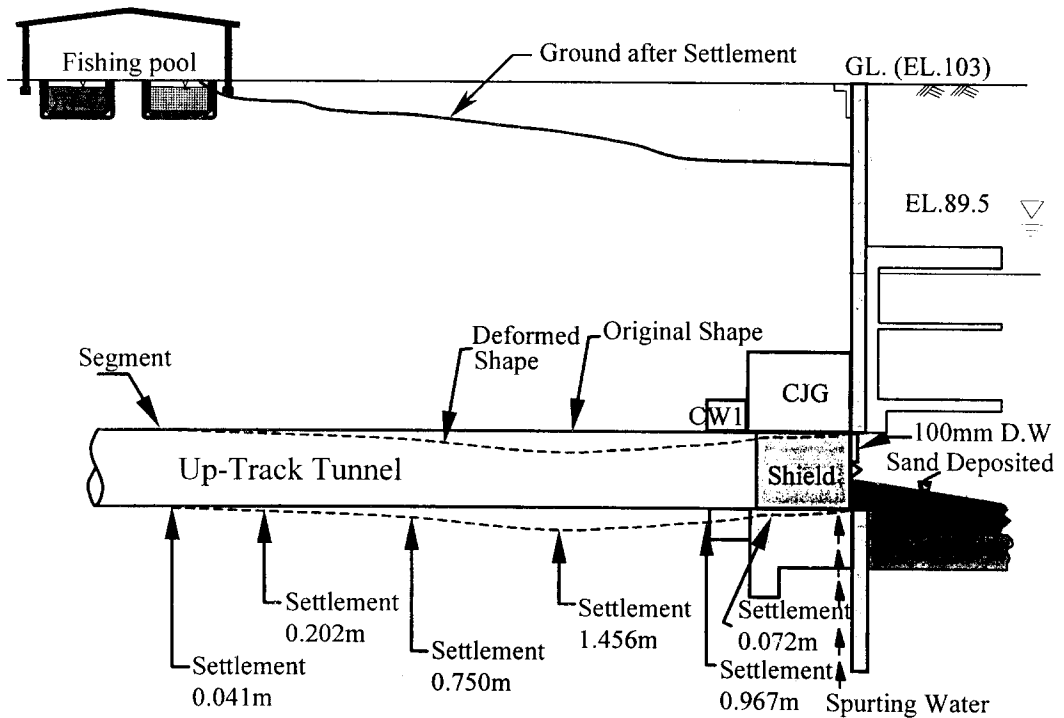
Figure 8 Settlement Profile at Arrival Shaft in Contract CP262

In a second case, both of twin tunnels were damaged when the shield machine for

driving the Up-Track tunnel arrived and opening was made on the diaphragm wall of the shaft, refer to Figure 8. Ground freezing was adopted to seal off the hole and rehabilitation was carried out in compressed air [3]. A large piece of timber was found at where water spurted as the invert was exposed. Right next to this piece of timber is a pvc pipe which was presumably once used for drawing water from the Chingmei Gravels. It is postulated that as the shield machine pushed the timber, the integrity of the treated ground was destroyed resulting in leakage. The situation would not have been so serious if this pvc pipe were not there because the Chingmei Gravels is at a level of 20m below the invert. This pvc pipe, about 225mm in diameter, became a water channel connecting to the Chingmei Gravels [3,5].
