LANDSLIDES IN TAIWAN
SOME CASE REPORTS

ZA-CHIEH MOH

*Proceedings, Advisory Meeting on
Earthquake Engineering and Landslides
29 August - 2 September, 1977, Taipei, R.O.C.*

SYNOPSIS Seven case histories of landslides are presented in the paper. These slides are of the types which are common in Taiwan. The major causes for the slides were either due to saturation of the soil mass after a heavy rainfall or due to high pore water pressure developed in the subsurface strata. Preventative, control or remedial measures adopted are described.

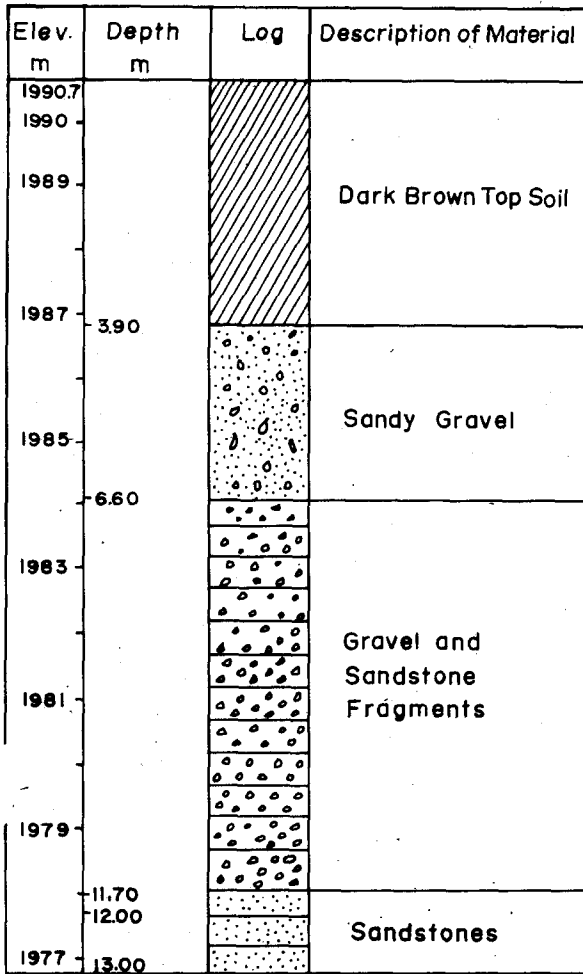
FIG. 12 TYPICAL SUBSURFACE PROFILE AT
PIN - ZAU - NAIR

condition was only about 20 to 60% of the strength in dry condition.
