# CAISSON FOR SLOPE STABILIZATION

W.S. Guo, L.W. Wong and K.I. Hsiung

*Reprinted from  
Proceedings, 9th Southeast Asian  
Geotechnical Conference, pp. 1-45 - 1-56  
Bangkok, 1987*

W.S. GUO  
*Moh and Associates, Inc.*  
Taipei, R.O.C.

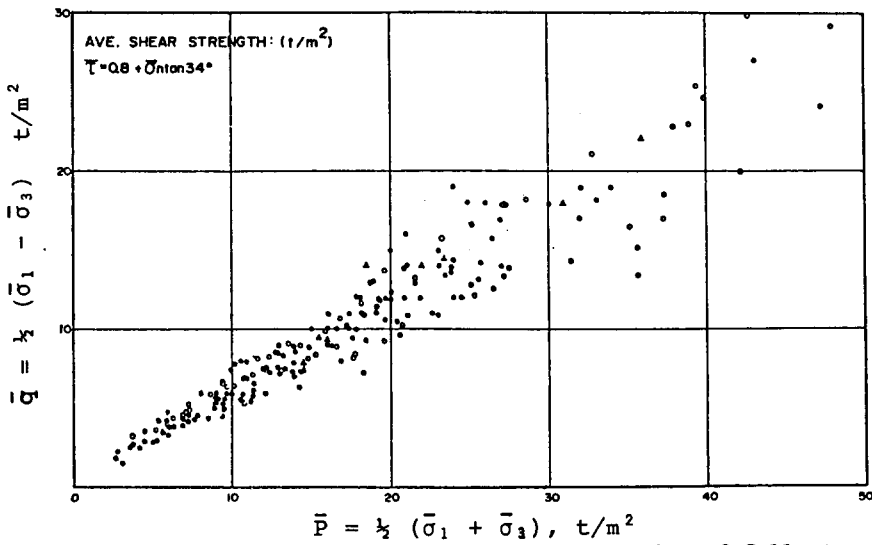
Fig. 6 Consolidated Undrained Triaxial Test Results of Colluvium

Triaxial consolidated undrained compression tests were conducted on the fine grained soil specimens and the results are summarized in Figure 7. The average effective shear strength envelope can be represented by Eq. 1;
