PIPING FAILURE OF A COFFERDAM IN SOUTHERN TAIWAN

*Reprinted from Proceedings of International Conference on
Foundation Failures
May 12~13, 1997, Singapore, pp.209~216*

Moh and Associates, Inc., Taiwan, ROC

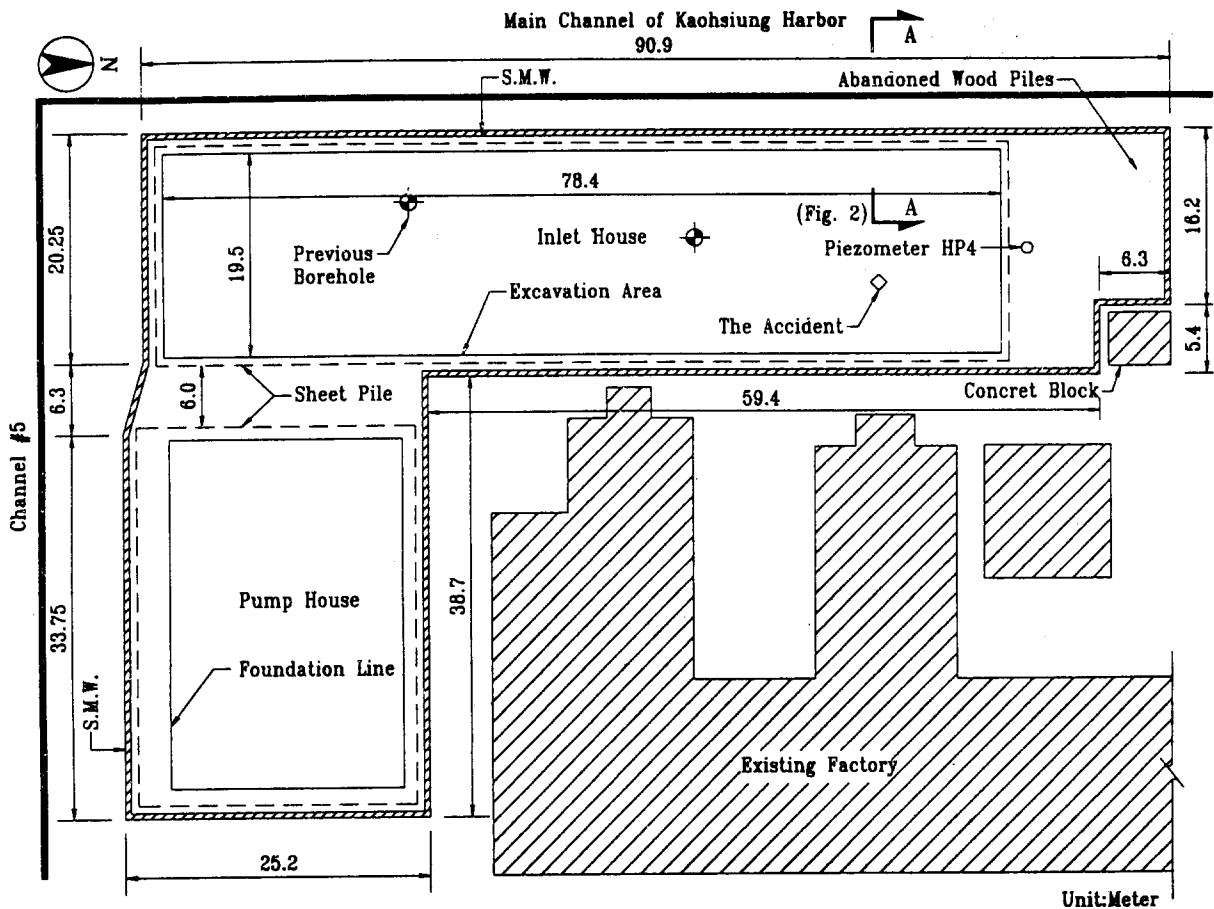
Fig. 1 General layout of site

As shown in Fig. 1, there were two excavations in this L-shape construction site, one for the Inlet House and one for the Pump House. The excavation for the Inlet House, which is the subject for discussion, was 78.4m in length, 19.5m in width and 13.75m in depth. It is separated from the Main Channel of Kaohsiung Harbor on its west by a pier of 2m in width and from Channel No. 5 on its south by a pier of 8m in width. On its east, an existing factory was in the vicinity and the excavation for the Pump House was only 6m away.

The layout of retaining walls is shown in Fig. 1 and a cross section of the west pier is shown in Fig. 2. The entire construction site is enclosed by soil mixing walls (SMW) of 0.6m in thickness and 32m in depth. In addition, a row of sheet piles (YSP IV) of 17m in length was installed to enclose the two individual pits. The SMW walls were reinforced by H-piles of 19m in length. The H-piles were spaced at 0.45m intervals on the west and the south sides of the excavation for the Inlet House and at 0.9m intervals on the north and the east sides.

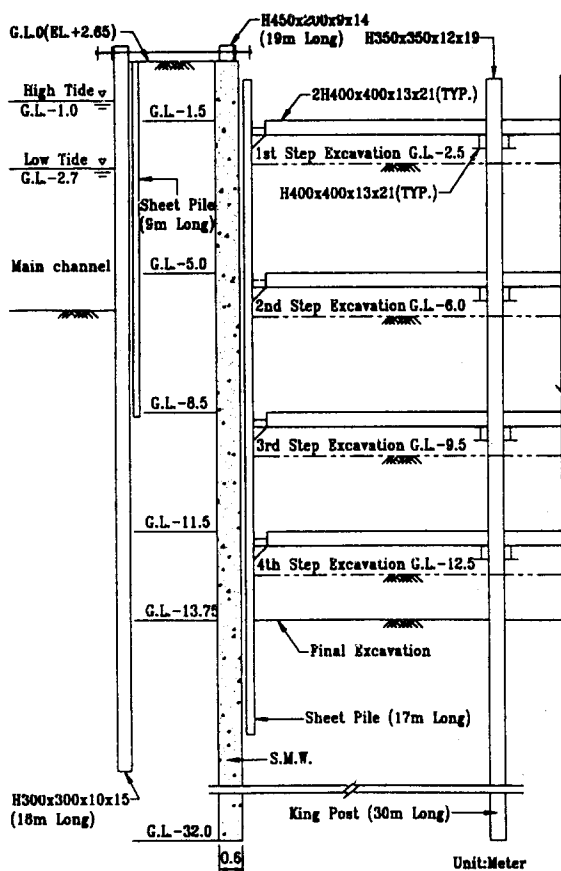
Fig. 2 Cross section A-A

As depicted in Fig. 2 the piers along the two

Channels were protected by sheet pile walls, 9m in length. To ensure safety during construction, steel H-piles, 18m in length, were driven at spacings of 2m alongside these sheet piles. They were tied to the SMW by steel rods at the top and the piers essentially became a double-wall cofferdam. The excavation for the Inlet House was braced by four levels of struts. The king posts supporting the struts were 30m in length and the piles supporting the platform, refer to Fig. 3 for locations, were 36m in length.
