A CASE STUDY OF PIPING FAILURE ASSOCIATED WITH SHIELD TUNNELLING

L.S. Lin, D.H. Ju and R.N. Hwang

*Proceedings of 15th International No-Dig '97, Taipei, Taiwan
November 26~28, 1997, pp.6B-1-1~6B-1-13*

SYNOPSIS: Making openings on diaphragm walls or base slabs is always a risky operation when the ground is permeable and water table is high. In 1995, piping failure occurred during the opening of one of the tunnel portals at an arriving shaft of the Panchiao Line in the Initial Network of the Taipei Rapid Transit Systems. It created a sinkhole of as deep as 6m and caused serious damages to adjacent structures and unacceptable distortions of tunnel segments. As a result, the construction was delayed by two years and the financial loss was tremendous.

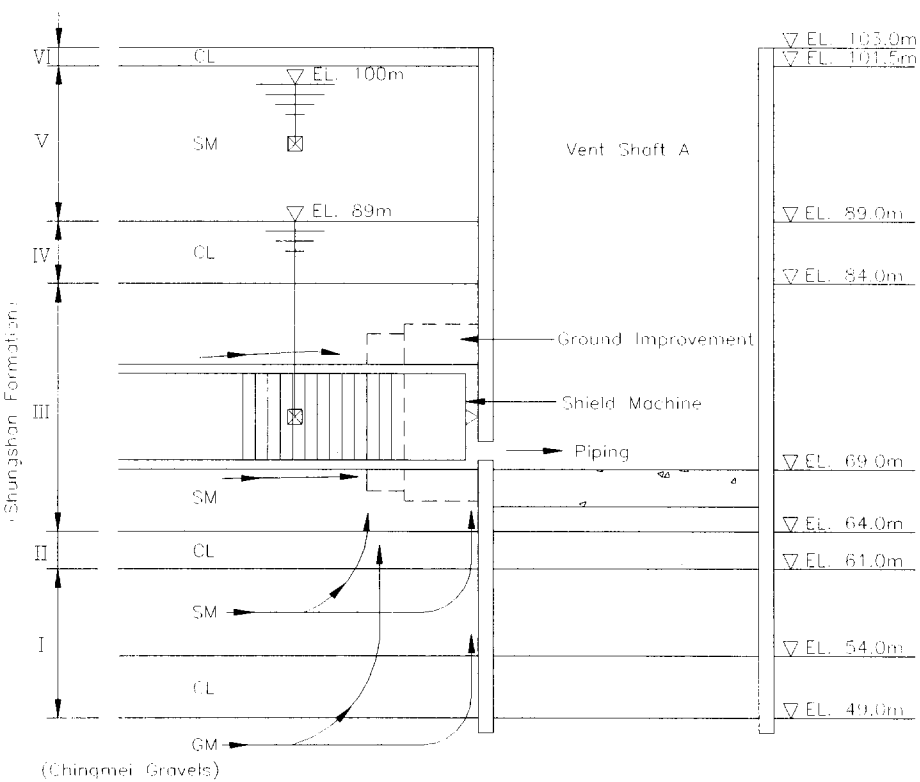
Fig.2 Soil Profile and Configuration of the Shaft

The site was located neighboring the southwest border of the Taipei City where the Tahan Creek joins the Hsintien Creek to become the Tamshui River. The subsoil at the site comprises alluvial deposit, i.e., the so-called Taipei Silts or the Sungshan Formation, to depths varying from 45m to 55m. Underlying the Sungshan Formation is a gravelly layer, i.e., the Chingmei Formation, which is extremely permeable and was once the sole source of water supply for the City of Taipei. A typical soil profile in this area, together with the configuration of the shaft, is shown in Fig. 2. The two tunnels are buried in a silty sand layer, i.e., Layer III in the Sungshan Formation, and the piezometric head at the inverts of the tunnels was about 200 kPa.
