# **GROUND FAILURES IN SOUTHEAST ASIAN COUNTRIES**

**Z.C. Moh, W.S. Guo and C.T. Huang**

*Reprinted from  
Proceedings, US-Asia Conference on Mitigating  
Natural Hazard Damage, Vol. 1, pp. c2/1-c2/24  
Bangkok, 1987*

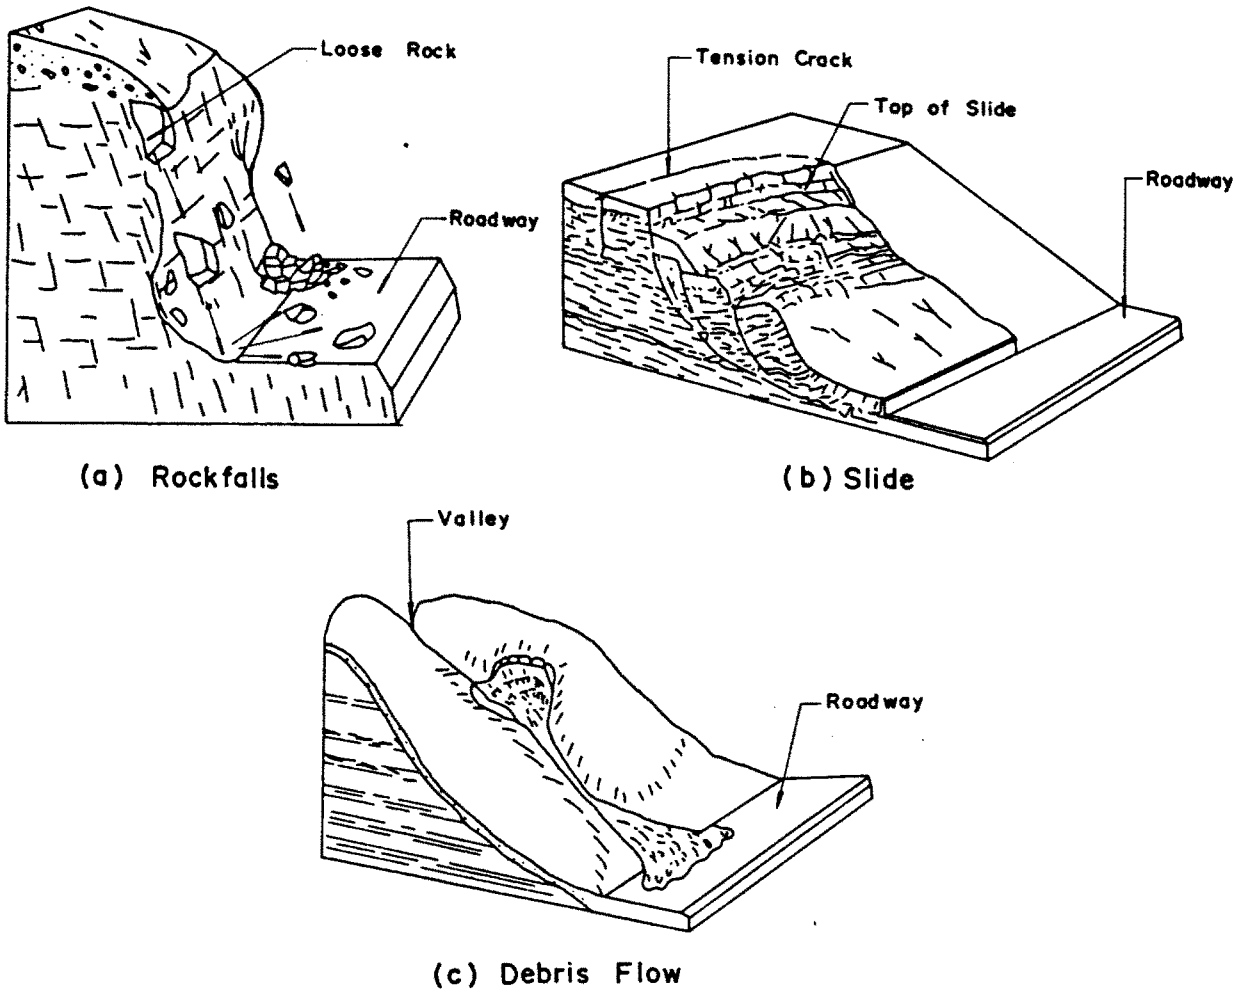
Fig. 5 Schematic Illustration of three most Commonly Occurred Types of landslide Along the Central Cross-Island Highway in Taiwan

Debris flow refers to movement of unconsolidated materials including rock fragments, cohesionless sand, cohesive soils and their combinations. As illustrated in Fig. 5 (c), debris flow usually does not have distinct sliding surfaces and are more surficial. The speed of movement is fairly rapid. They are commonly found in steep valleys after heavy rains. A thorough investigation was carried out in the three study areas to identify potential instability of the side slopes along the highway. Included in the investigation were landform, topography, geological condition, vegetation, existing slope protection measures, past hazard records, and etc. A total of 388 locations were studied. Among them, rockfall (including some soil falls) has been identified as the most common type of potential hazard (Table 2).

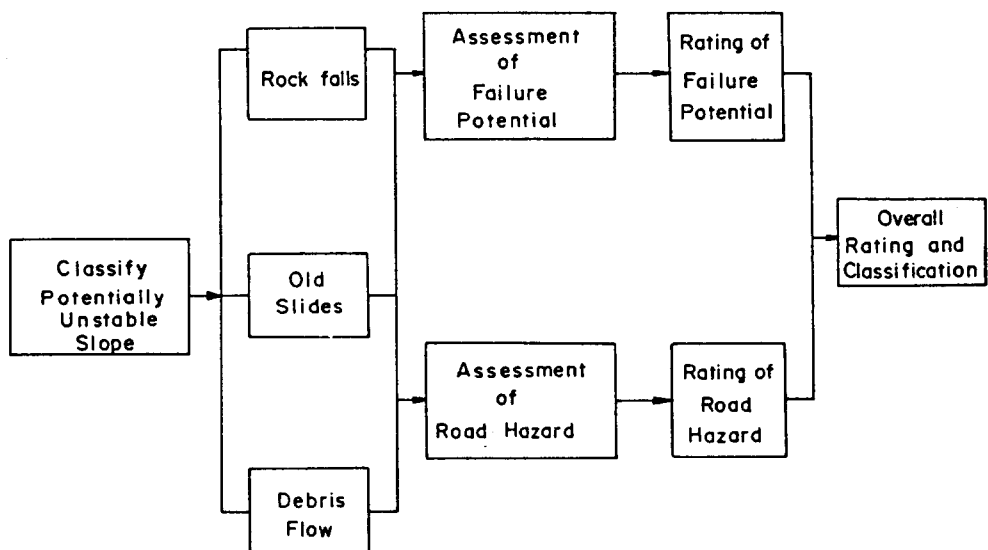
Fig. 6 Flow Diagram for landslide Assessment

Figure 6 (a) shows the flow diagram of processes involved in the slope assessment work. The assessment and rating of the 388 potentially unstable slopes were carried out following the flow diagram shown in Fig. 6 (b). Besides identifying the type of potential slope failure, two major factors are considered. They are potential of failure and hazard to road usage. Semi-quantitative ratings are introduced into the assessment in order to arrive at a final rating. The following sections describe briefly the methodology adopted for the recommended rating system.

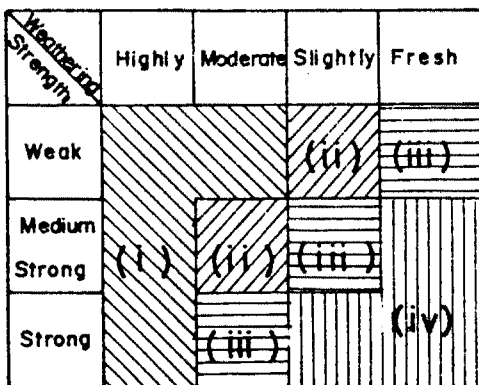
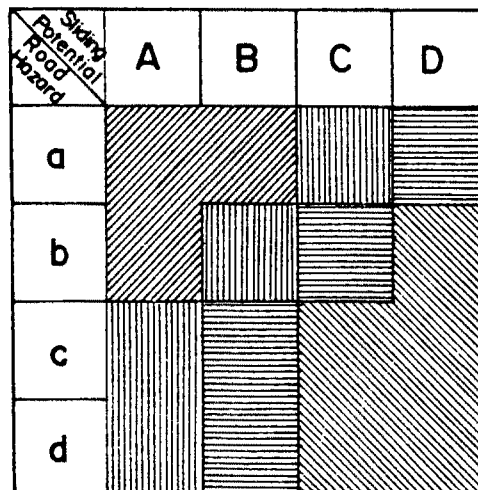
Note: Rock Strength and degree of Weathering Classifications after ISRM (1981)

▨: I    ▤: II    ▥: III    ▧: IV

Fig. 7 Rock Strength and Weathering Intensity

\* Refer to Fig. 7
