# **PORE PRESSURE RESPONSE TO SHIELD TUNNELLING IN SOFT CLAY**

R. N. Hwang, D. J. Wu and C. J. Lee

*Reprinted from Proceedings of South East Asian Symposium  
on Tunnelling and Underground Space Development  
January 18~19, 1995, Bangkok, Thailand, pp.33-40*

**ABSTRACT:** Presented herein are the data obtained for a section of tunnel driven in the K1 Zone of the Taipei Basin with the aim of understanding the porewater pressure response to shield driving. It has been found that tremendously high excess porewater pressures were induced but their distribution is limited to a distance of one diameter from the edge of the tunnel.

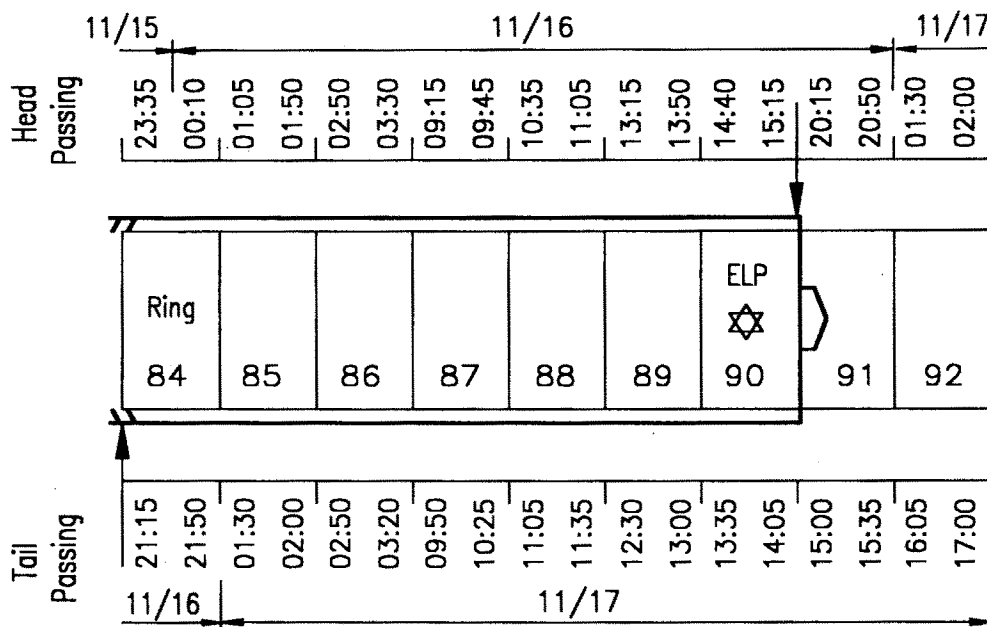
Fig. 2 Progress of Tunneling

The Up-Track tunnel was launched first and the shield machine passed this instrumented section on July 3, 1993. For the Down-Track tunnel, the shield machine passed the section on November 16 and 17, 1993. Since more data are collected during the driving of the Down-Track tunnel, the detailed progress of this drive is shown in Fig. 2 for later reference. Field records show a total thrust of 798 tons was applied to the shield and it took 31 minutes to complete the excavation for Ring 90, where the section is located, giving a speed of 33 mm/min. The quantity of the slurry injected into the earth chamber is 1612 liters and a total of 27.03 m<sup>3</sup> of sludge was removed. The total earth pressures in the chamber were monitored by 4 pressure cells and readings indicate an average of 1.73 kg/cm<sup>2</sup> during shoving with a maximum of 2.02 kg/cm<sup>2</sup>.

A close-up of the readings taken in the 2-day period in which the shield machine in the Down-Track tunnel passed the section is given in Fig. 4. For simplicity, only the readings taken by those piezometers close to the tunnel are presented. The data shall be read in conjunction with the dates given in Fig. 2 for correlation with the progress of tunneling. Porewater pressure response was perfectly in phase with the movements of the shield. For example, on November 16, the day-shift started at 8:15 with the erection of Ring 82 after a long pause overnight. Piezometers indicated minute, but evident, reductions in porewater pressures. The reductions could be a result of disturbance to the ground due to the operation of the segment erector. Excavation for Ring 87, which is 3m ahead of the section of interest, started at 9:15 and ended at 9:45, and piezometers responded to the event faithfully.

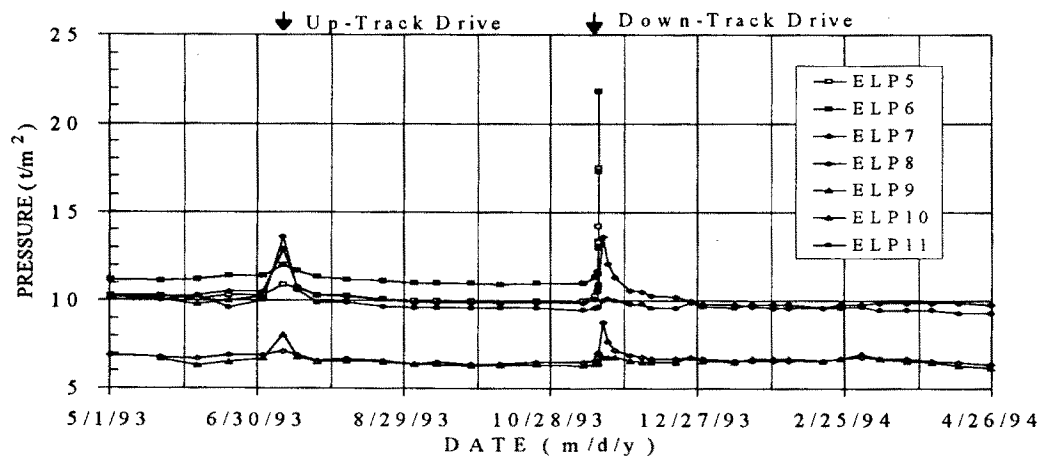
Fig. 3 Pore Pressure Readings

Porewater pressures were monitored by using electrical type piezometers (ELP) and the positions of these piezometers are depicted in Fig. 1. The readings taken are shown in Fig. 3. As can be noted, significant positive excess porewater pressures were recorded as the shield machines approached and passed the section.

The final readings indicate a slight drawdown of the groundwater table. This was frequently observed for other tunnel drives and the reason for this to happen is unclear at this moment. It might have something to do with seepage flow into the tunnels as a result of leakage which is extremely difficult to totally prevent. In any case, the magnitude of the drawdown is too small to worry about.

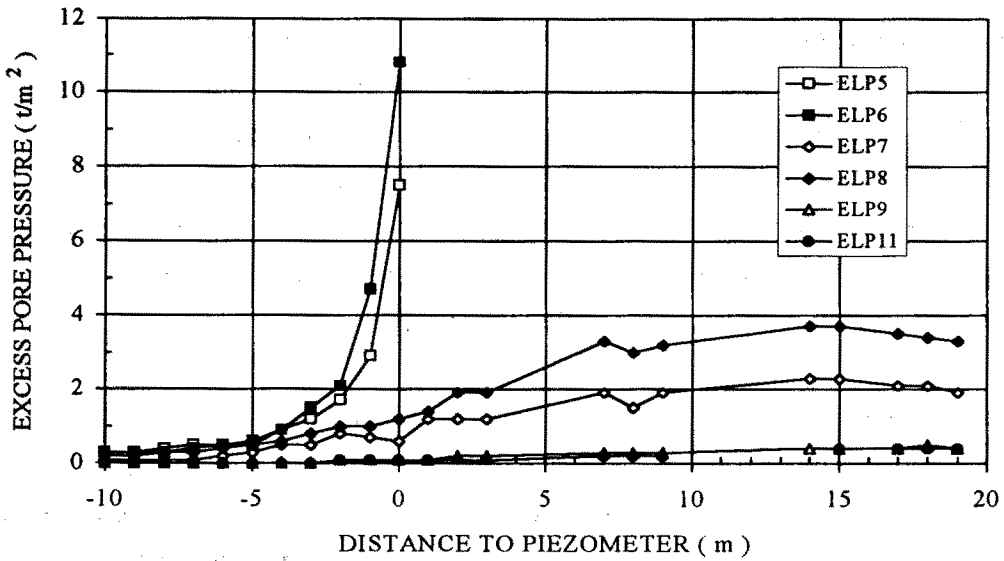
Fig. 5 Excess Pore Pressures Versus Distance ( Down Track )

The excess porewater pressures induced are plotted against the positions of the head in Fig. 5. The trend of increasing pressure as the shield approached and passed the section is readily apparent. The all-time highs of the excess porewater pressures for the two drives are shown in Fig. 6 and Fig. 7. For the Up-Track drive, the head passed the section between 15:05 and 15:45 of July 3 and the tail passed the section between 11:20 and 11:49 of July 4. Readings were not taken in the period between July 2, and July 10, therefore, peak response could have been missed. This explains the fact that less excess porewater pressures were recorded during the driving of the Up-Track tunnel. ELP-10 became inoperative on July 10. It is unsure

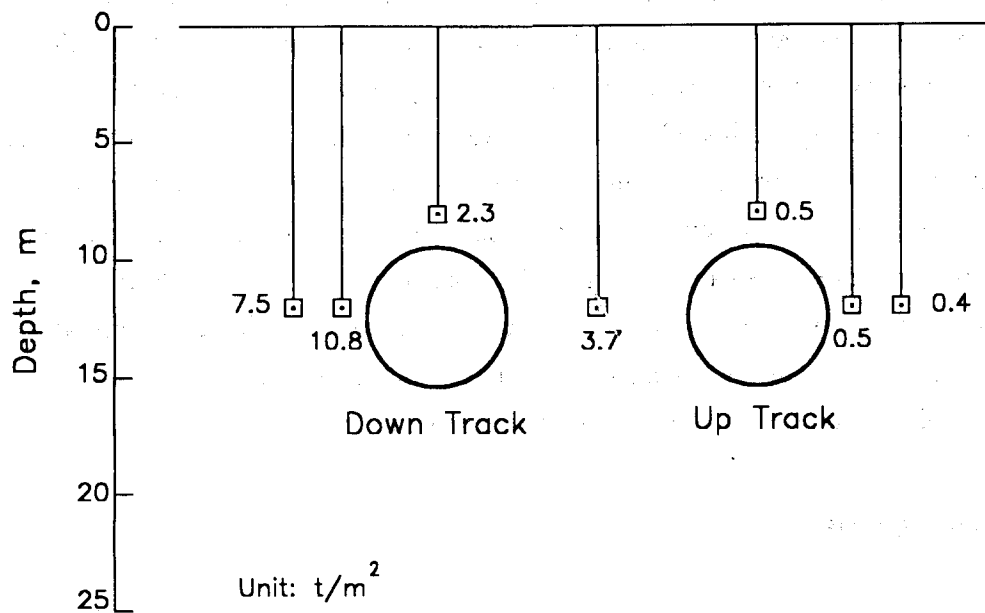
Fig. 7 Maximum Excess Pore Pressures due to Driving of Down-Track Tunnel

exactly when it was damaged. For the Down-Track tunnel drive, since reading of ELP-5 was steady, it is unsure whether the uprising reading taken by ELP-6 at 14:50 can be trusted.

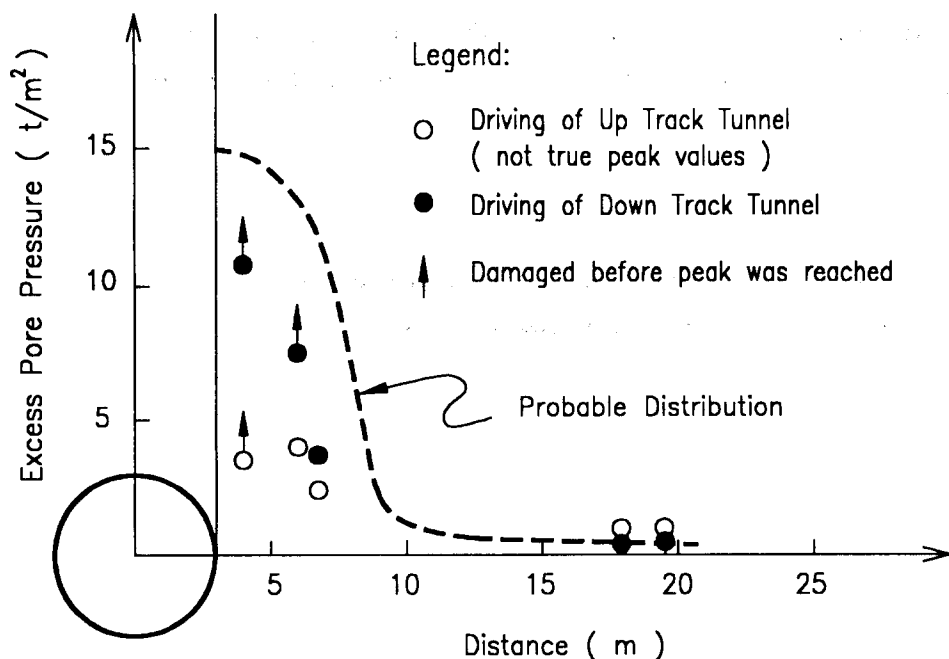
Fig. 8 Excess Pressures at Springline Level

Naturally, the piezometers closer to the tunnels give greater excess porewater pressures. This will be clear from Fig. 8 which shows the variation of excess porewater pressures with distance. If a threshold of  $1 t/m^2$  is adopted, the porewater pressure response is found to be limited to 6m, or one diameter from the edge of the tunnel.
