Geotechnical History of the Development of the Suvarnabhumi International Airport

Za-Chieh Moh
P.C. Lin

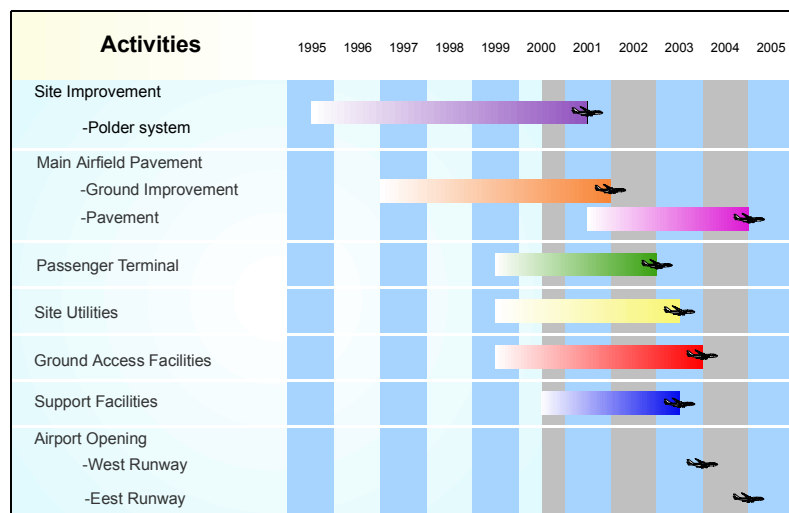
Figure 1 Construction Schedule of Major SIA Activities

The construction of Suvarnabhumi International Airport (or Second Bangkok International Airport) has been planned since 1960 to accommodate the rapid growth of air traffic in this region. The Suvarnabhumi International Airport (SIA) will not simply provide additional airport capacity to supplement the existing Bangkok International Airport at Don Muang, but will also develop the Bangkok into an international aviation hub in Southeast Asia. The new airport project since the initial planning in 1961 has passed 16 Prime Ministers and 30 Cabinets and was finally approved for construction in May 1991. The first phase of Suvarnabhumi International Airport is scheduled to open in September 2005 with capacity to deal with 40 million passengers and 1.46 million tons of cargo per year. In the future, the new airport will be able to serve 100 million passengers and 6.40 million tons of cargo annually. The New Bangkok International Airport Company Limited (NBIA), a state-enterprise under the Ministry of Transportation and Communications, was formed in February 1996 to implement the SIA construction. Total construction cost is estimated to be more than 120 billion Thai Baht and in which, over 60% will be used for engineering cost. In December 2001, the construction of passenger terminal building, a major milestone, has been finally launched. Figure 1 shows the construction schedule of major SIA facilities.

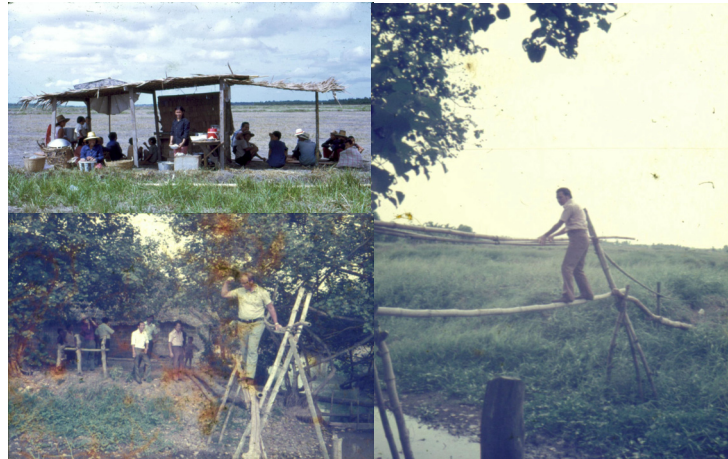
Figure 4 Nong Ngu Hao in 1973

Access to the SIA site in the early year was extremely difficult since most of the area were swamps and canals. The engineering team sometimes had to utilize bamboos to build temporary bridges for crossing the canals and hut to work and live in (Figure 4). A total of 28 soil borings and 64 vane shear borings were taken at site during this study. Four test sections without ground treatment underneath had been carried out by AIT in 1973 which are:

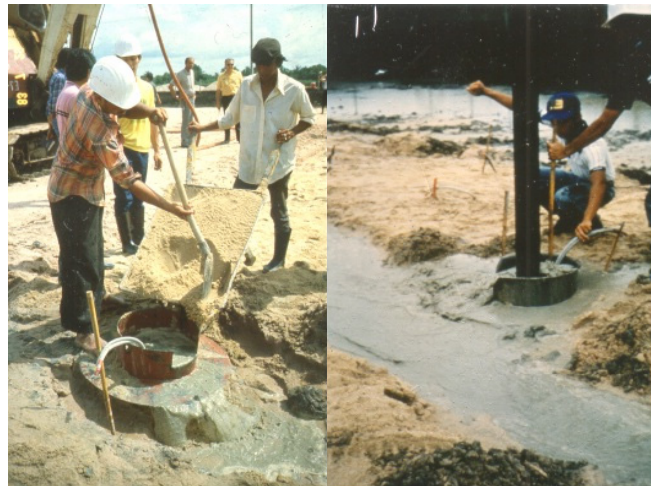
Figure 5 Sand Drains Installation (1983~1984)

During this preliminary master plan study, field testing program including three testing embankments: TSI using groundwater lowering technique by pumping with installed instruments, TSII with embankment surcharge fill and TSIII using vacuum loading, were conducted at the SIA site. A total of 11 boreholes, 40 electric cone penetration tests and 40 pore pressure probe tests were carried out. Non-displacement sand drains (0.26m diameter) were installed to 14.5m depth at 2m spacing in triangular pattern (Figure 5). Maximum settlements of 86cm, 126cm and 66cm were recorded for embankment TSI, TSII and TSIII with loading ranged from 6 t/m² to 8t/m², respectively. This study

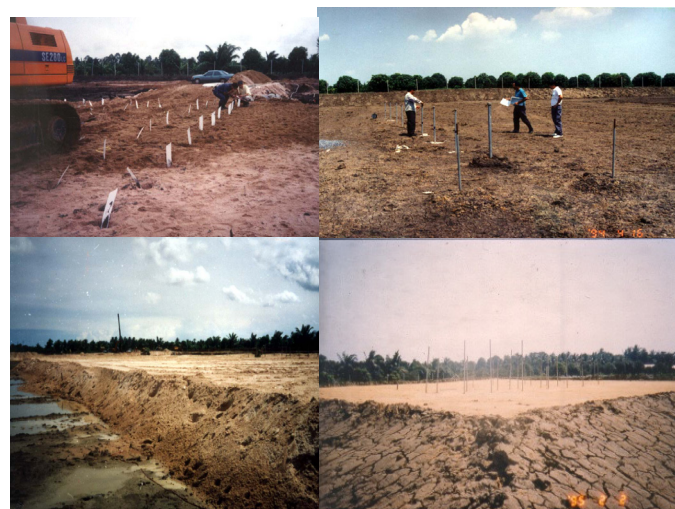
Figure 7 AIT Test Embankments at Nong Ngu Hao

Full-scale PVD test embankments (Figure 7) were conducted at the SIA site after the conclusion made by STS/NGI during the independent soil engineering study. Three 4.2m high (75 kPa) test embankments (40m x 40m) with PVD spacing of 1.0m, 1.2m and 1.5m in square pattern to 12m deep were constructed.

inclinometers were installed to evaluate the ground improvement technique by using PVD. The final measured settlement at 6 months after full fill height was about 152cm, 138cm and 128cm, for PVD spacing of 1.0m, 1.2m and 1.5 m, respectively. A total of 3 boreholes and 6 vane shear borings were carried out at site before test embankment construction. In conclusion, the study recommended that PVD is a suitable technique for the accelerated consolidation of Bangkok Clay at the SIA site provided a very careful design of the PVD system to minimize any possible adverse effect due to hydraulic connection with the first sand layer located at 22m depth. Proper drainage system to allow for the free discharge of excess pore water was also remarked.

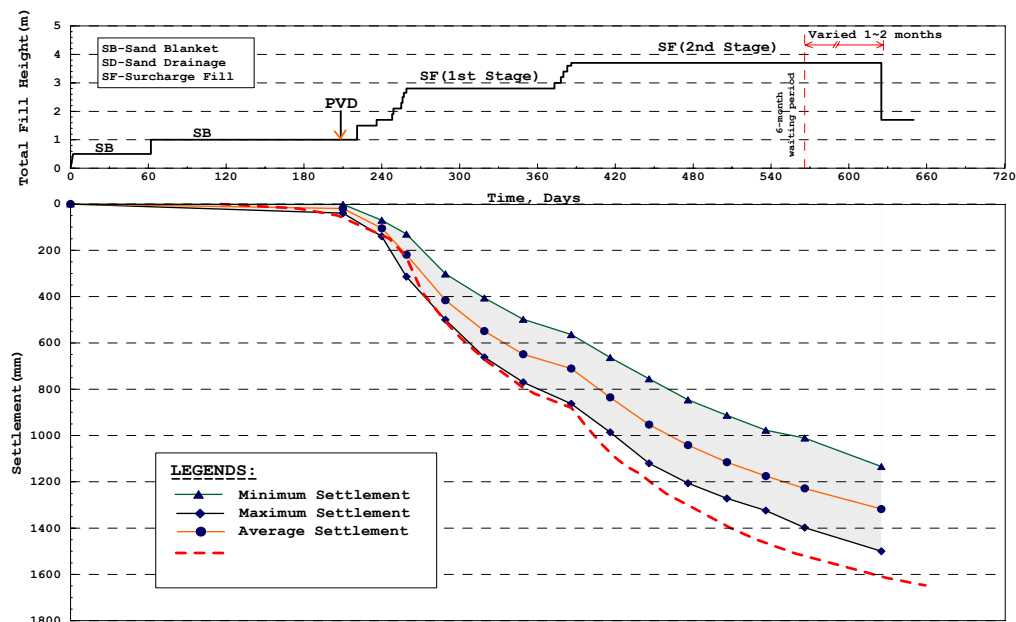
Figure 14 Comparison of Field Settlement and Design Curve at Apron (under 75 kPa)

In general, field surface settlement was about 10~20% less than the design estimated settlement at end of waiting period, and the actual time for surcharge removal was about 1 to 2 month(s) longer than the minimum requirement mainly to satisfy the settlement ratio of removing criteria. Therefore, final settlement prior to surcharge removal, as shown in Table 2 and Figure 14, is 5~15% less than the design value. However, uniform settlement over the improved area was observed and the area with higher surcharge load encountered more settlement as expected.

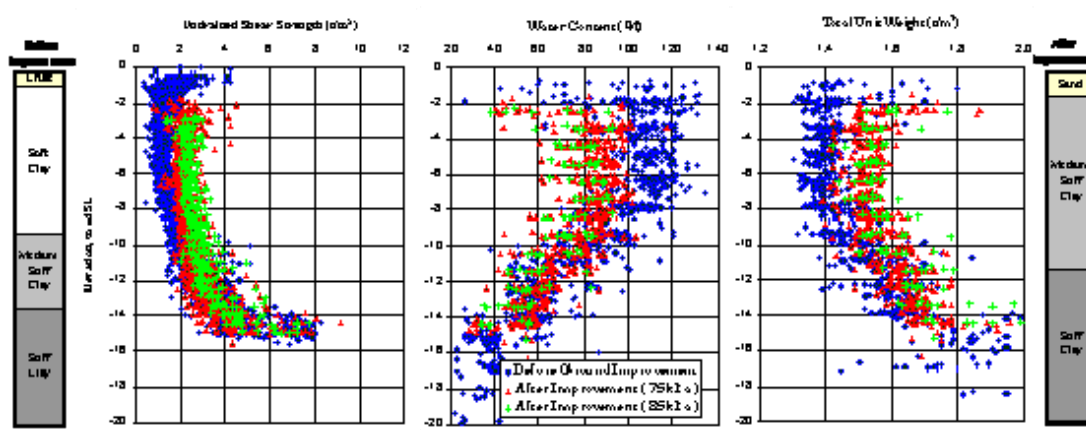
Figure 18 The Comparison of Soil Properties before and after Ground Improvement

Beside the monitoring data, the change of soil properties within the soft clay layer of ground improvement area will also be an important indication to evaluate the ground improvement performance. Major considerations were made to the natural water content, total unit weight, field undrained shear strength and cone resistance of PCPT. In general, reduction of 25 to 35% of natural water content was observed within the soft clay layer (mostly between 2 to 8m depth) after ground improvement. The decrease of water content should also result in increase of total unit weight of the underneath soft clay. In average, a total of 10 to 15% increase in total unit weight after ground improvement was obtained. The undrained field vane shear strength obtained from field vane shear tests increased up to twice of its original value. Uniformed improvement has been observed in all areas. The upper “very soft to soft clay” has been improved to “medium stiff clay” according to the soil properties. Figure 18 shows the comparison of soil properties including water content, total unit weight and undrained field vane shear strength before and after ground improvement areas.
